Technical Report to the Springvale Station Erosion Management Plan

Cape York Natural Resource Management 2017

The Springvale Station Erosion Management Plan presents a summary of the recommended implementation approaches for reducing sediment loss from Springvale Station (www.qld.gov.au/environment/coasts-waterways/catchment-management/springvale-station).

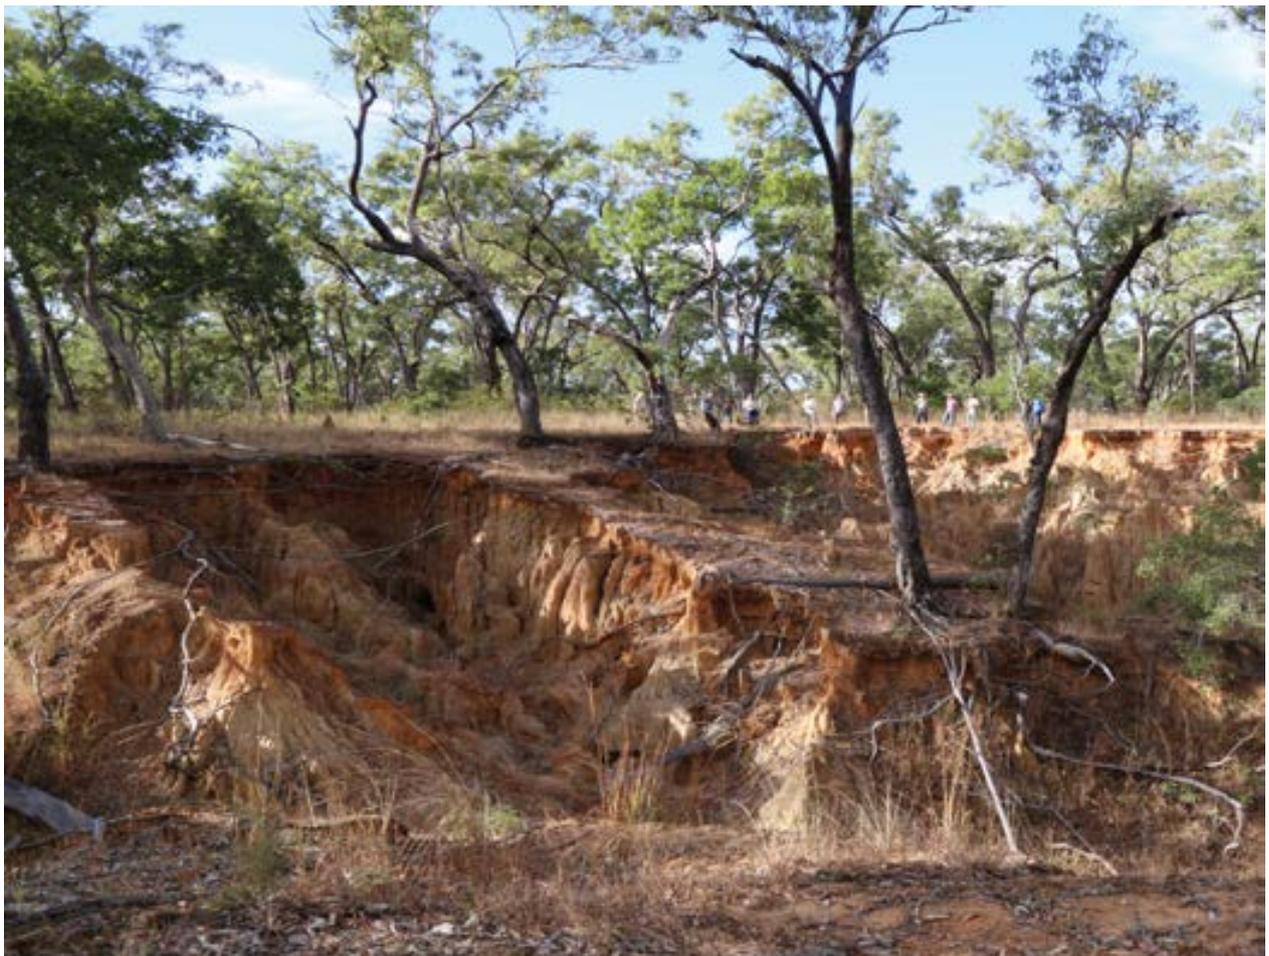
Figure 1 The Springvale Erosion Management Plan Project Team inspecting a mature alluvial gully adjacent to Keetings Road on Springvale Station (5th June 2017) (Source: Lyndal Scobell).

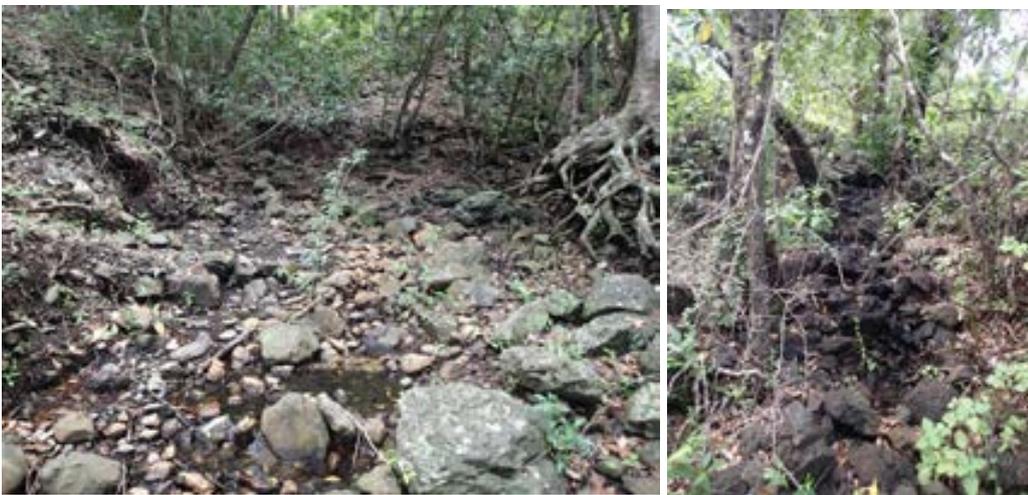
Figure 10 Gully and creek channels draining basalt plateaus on Springvale Station (Plum Creek headwaters) (Source: Jeff Shellberg).

Erosion into the basalt formation and soils can take several forms. While basalt rock and soil is very porous, overland sheet flows can still occur during heavy rainstorms (infiltration excess runoff) and lead to sheet erosion. Sheet erosion is most common toward the edges of basalt plateaus where the slope and rocky nature of the soil profile increases (Figure 9), or where soils are disturbed and compacted by machinery. The steep edges of basalt plateaus lead to the formation of rill, gully and creek channels (Figure 10). These slope inflection points are often where spring water emerges after infiltrating through the basalt plateau. Channel erosion can be enhanced at these spring areas where both surface and subsurface water meet (Figure 10).

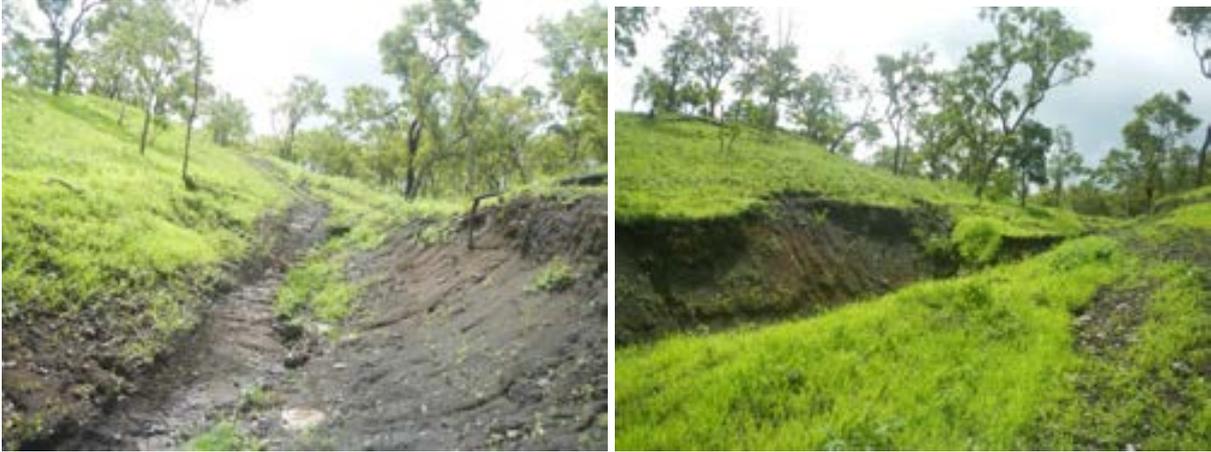
Figure 11 Colluvial gully erosion into basalt on the edge of a plateau, accelerated by road use, machine disturbance, and excess water runoff on Springvale Station (Source: Jeff Shellberg).

Accelerated gulying into basalt soils can be found near plateau edges where human land use disturbance cuts into soil profiles and colluvium. Roads and fence-lines cut into the soil lead to concentrated erosion, and can cause rill and deep gully erosion (Figure 11; Figure 12; Figure 13). Cattle pads cut into basalt soils also can lead to concentrated flow and rill erosion (Figure 9; Figure 13). Soil erosion on alluvial flats with semi-structured clay or loam soils can be enhanced by tree clearing disturbance, soil tillage, and farming (Figure 14). Erosion on these flats is mostly concentrated along small ephemeral drainage lines, which can be incised from gully erosion enhanced by reduced vegetation cover and enhanced water runoff (Figure 14). Gulying can be especially pronounced at the edges of flats where slope increases (Figure 13; Figure 14; Figure 15). Springs are common within the basalt geology, and create many wetlands, boggy hollows and channel-less valleys, and perennial reaches of creek (hence 'Springvale'). Cattle are attracted to the wet spring areas, and can consume large amounts of grass and trample banks and spring heads. This disturbance can promote bank erosion and channel incision, leading to gulying of these wet areas (Figure 16). In time, spring water can be reduced as gulying drains local wetland areas.

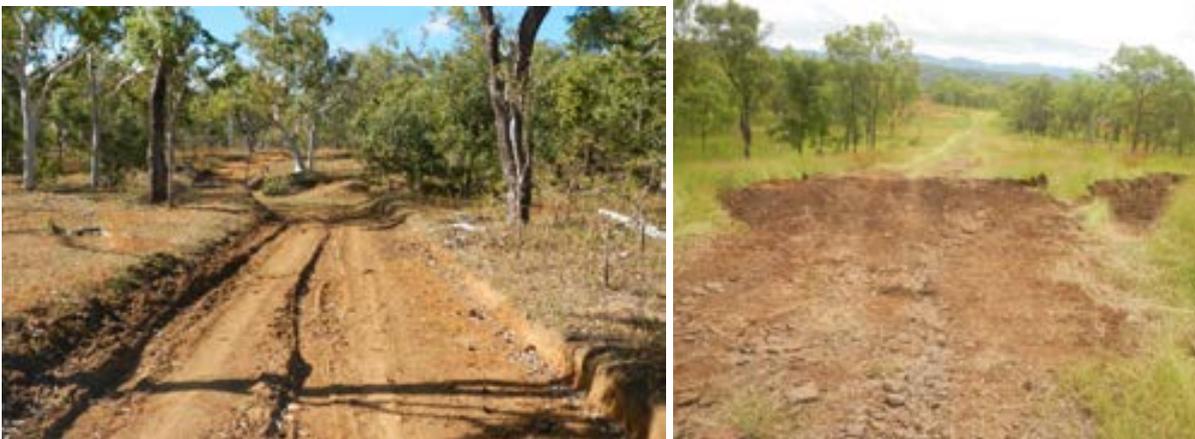
Figure 12 Road erosion into basalt on Springvale Station (Source: Jeff Shellberg).

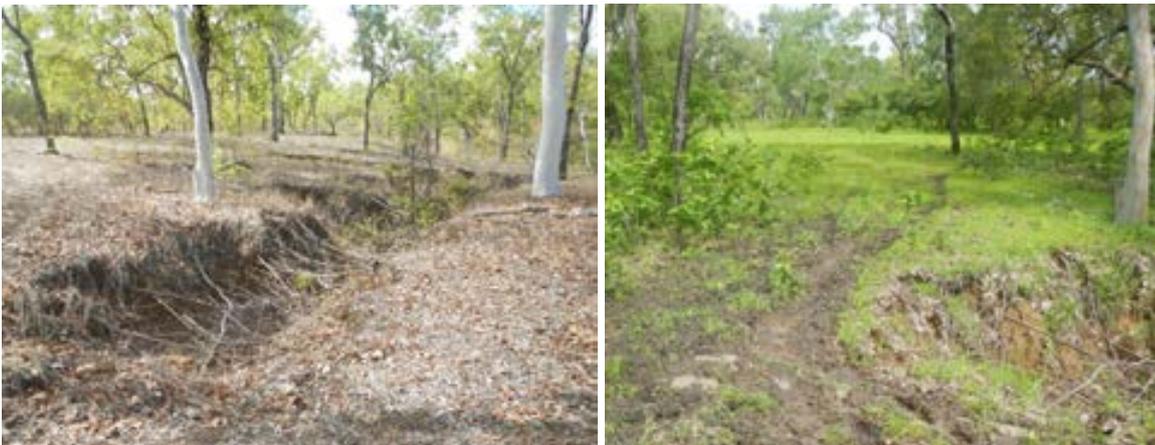
Figure 13 Colluvial gully erosion into basalt, accelerated cattle pad, grazing and road disturbance on Springvale Station (Source: Jeff Shellberg).

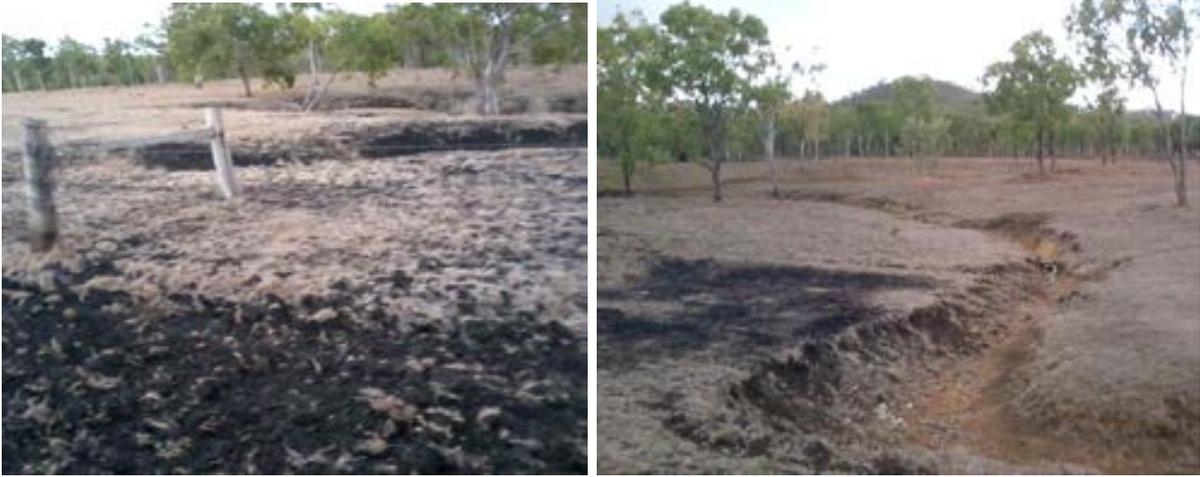
Figure 14 Colluvial gully erosion into basalt soils cleared and tilled for improved pasture on Springvale Station (Source: Jeff Shellberg).

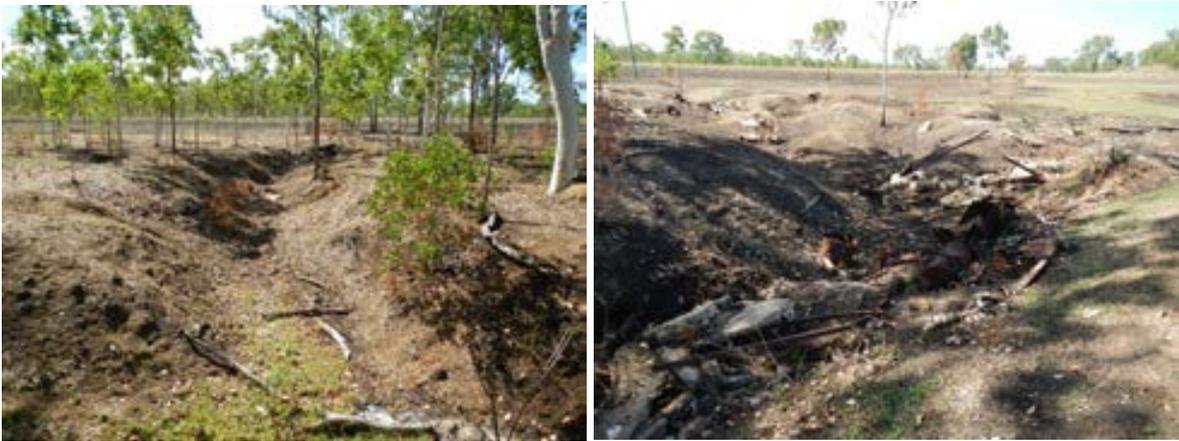
Figure 15 Colluvial gully erosion into basalt on Springvale Station, accelerated by land use disturbance (Source: Jeff Shellberg).

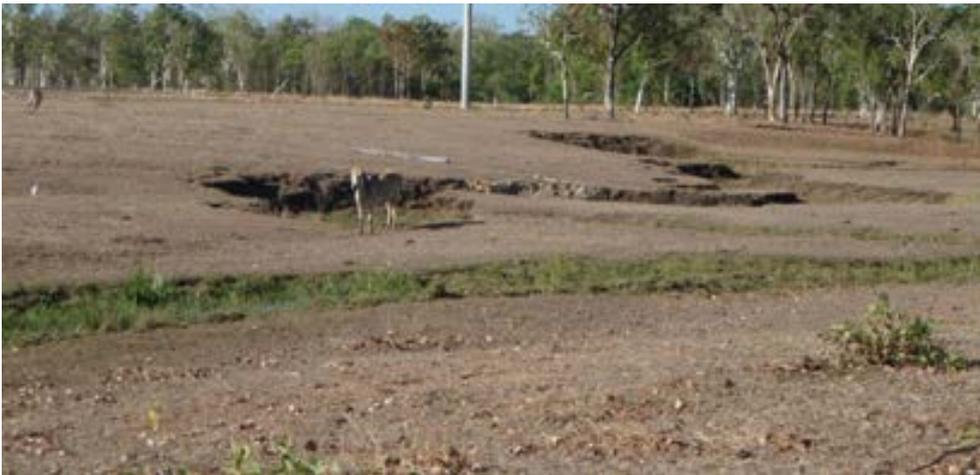
Figure 16 Gully erosion into a spring fed basalt tributary on Springvale Station, accelerated by land use disturbance (Source: Jeff Shellberg).

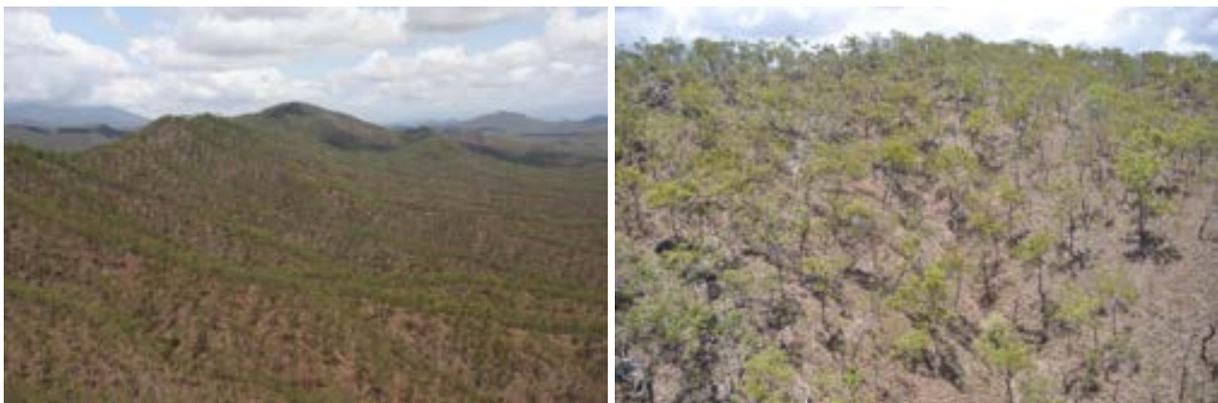
Figure 17 Dissected hillslopes and narrow valleys within the Hodgkinson Formation on Springvale Station (Source: Jeff Shellberg).

Erosion on the hillslopes of the Hodgkinson Formation is dominated by sheet erosion and some rilling (Figure 17). Hillslope erosion rates were measured at several adjacent sediment traps in the Hodgkinson Formation in greywacke units on neighboring Kings Plains Station and found to be very low under moderate grazing pressure (0.01 – 0.03 t/ha/yr; Brooks et al. 2014). Erosion rates in more erodible siltstone and mudstone units of the Hodgkinson Formation have not been measured, and could be higher than reported above, as could different slope positions and forms (planar, concave, convex). Overall, the rocky skeletal nature of soils on these Hodgkinson hillslopes and their tendency to form surface stone lags act as a semi-effective non-vegetative cover (Figure 17). Natural vegetation cover from kangaroo grass and Eucalyptus woodlands are still important mediators in enhancing slope and soil stability (Figure 17). Wildfires are common in the remote parts of the Hodgkinson Formation and can disrupt the balance of slope and vegetation cohesion, as can cattle grazing. While most slopes are semi-stable with pockets of colluvial erosion in hollows (Figure 18a), other slopes have been stripped of soil down to sub-soils, lags of gravel, and bedrock due to excessive grazing pressure (Figure 18b).

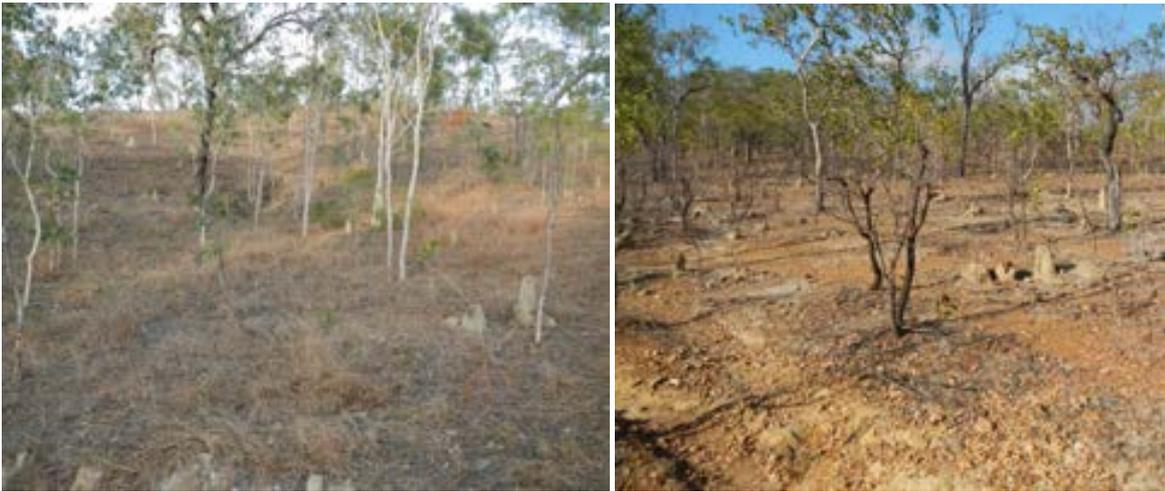
Figure 18 Semi-stable and unstable hillslopes in the Hodgkinson Formation on Springvale Station (Source: Jeff Shellberg).

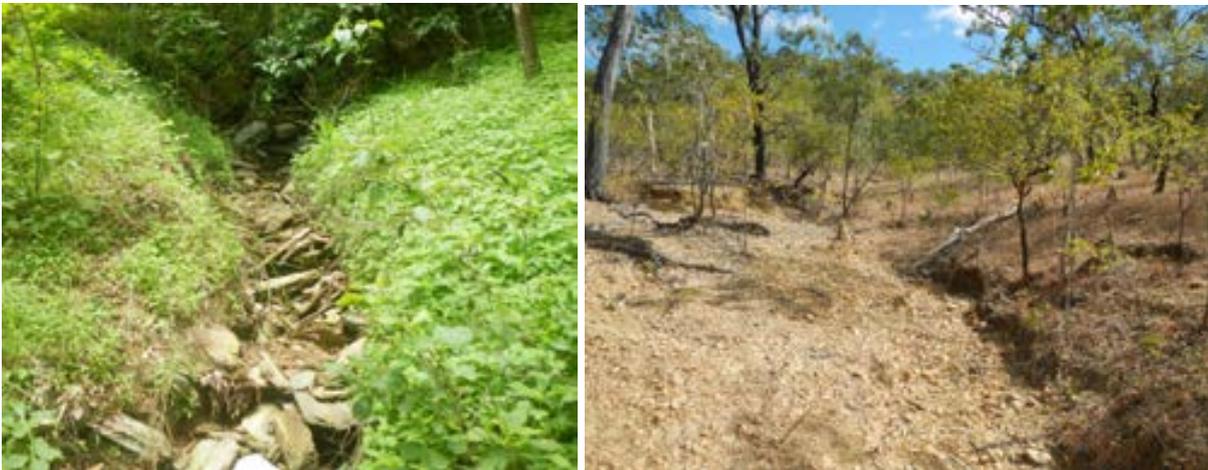
Figure 19 Semi-stable and unstable headwater stream channels in the Hodgkinson Formation on Springvale Station (Source: Jeff Shellberg).

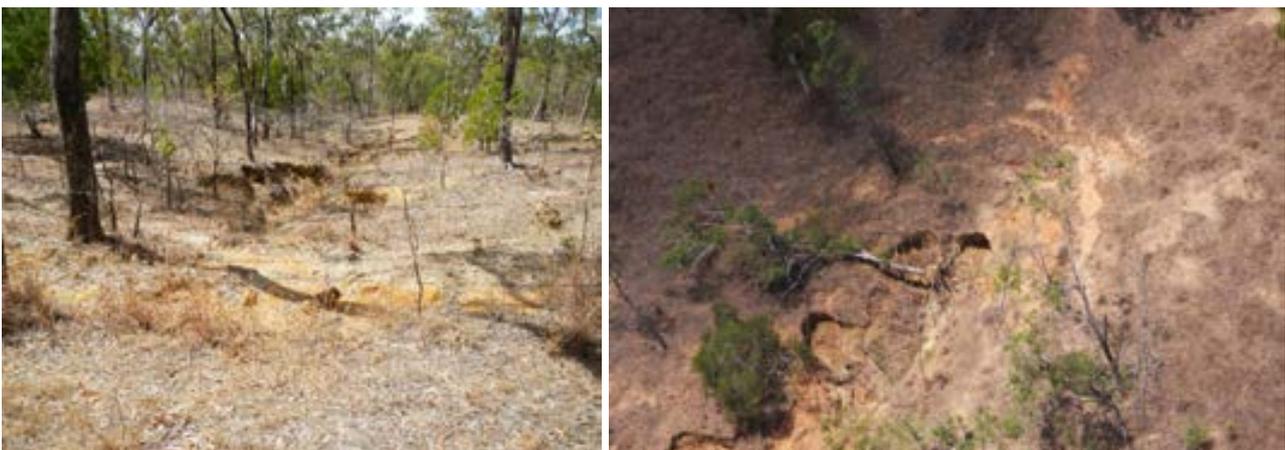
Figure 20 Colluvial gully erosion into hillslope hollows (colluvium) within the Hodgkinson Formation on Springvale Station (Source: Jeff Shellberg).

Colluvial gully erosion within the thousands of narrow bedrock valleys within the Hodgkinson Formation is common, along with associated sheet and rill erosion (Figure 20; Figure 21). This incisional erosion into previously intact colluvial hollows can be both a natural process and once accelerated by land use (grazing, fire, loss of vegetation cover, excess water runoff, roads, fences). Roads and fence-lines cut by machinery and ongoing use has destabilized many soil profiles, delivered fine sediment (mudstone, siltstone products) to local creeks, and promoted channel incision, gullying, and local bank erosion in small creek channels (Figure 22; Figure 23; Figure 24). Cattle pads cut into hillslopes has also promoted rilling and gullying (Figure 21).

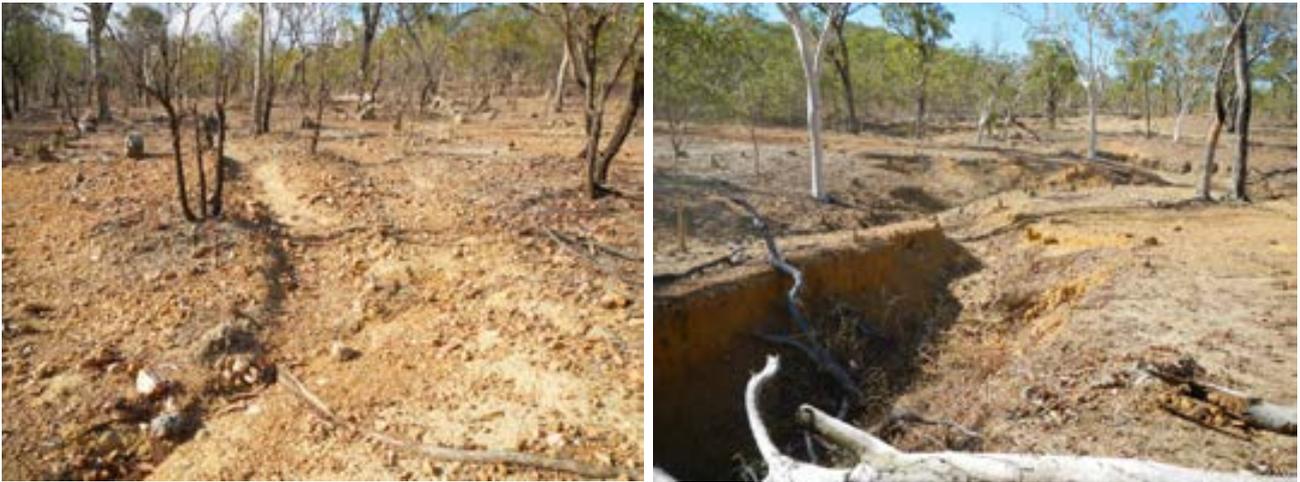
Figure 21 Sheet, rill, and colluvial gully erosion within the Hodgkinson Formation on Springvale Station (Source: Jeff Shellberg).

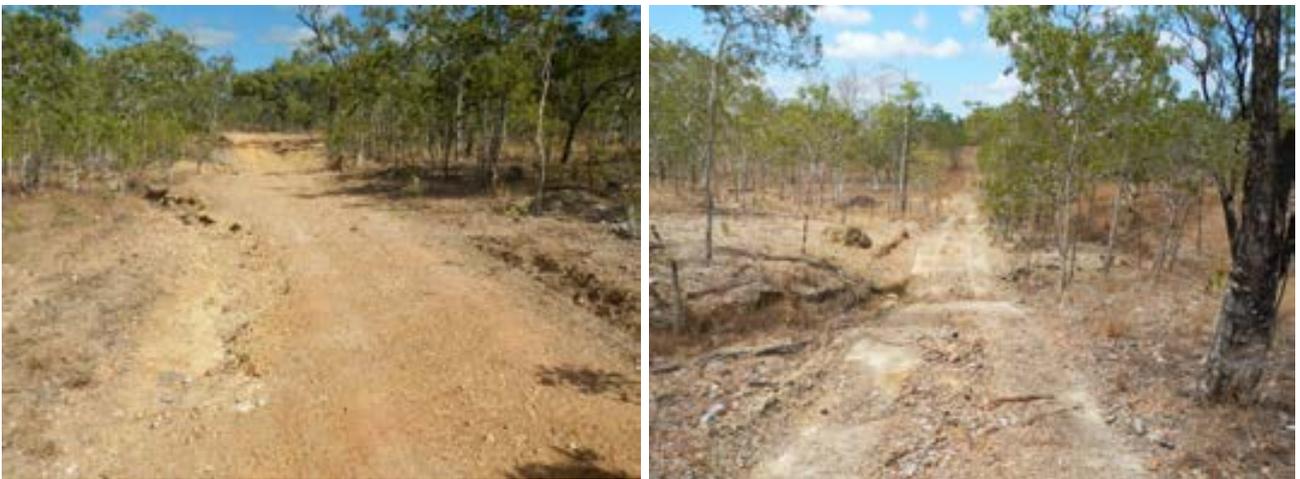
Figure 22 Road erosion (sheet, rill and gully) in the Hodgkinson Formation on Springvale Station (Source: Jeff Shellberg).

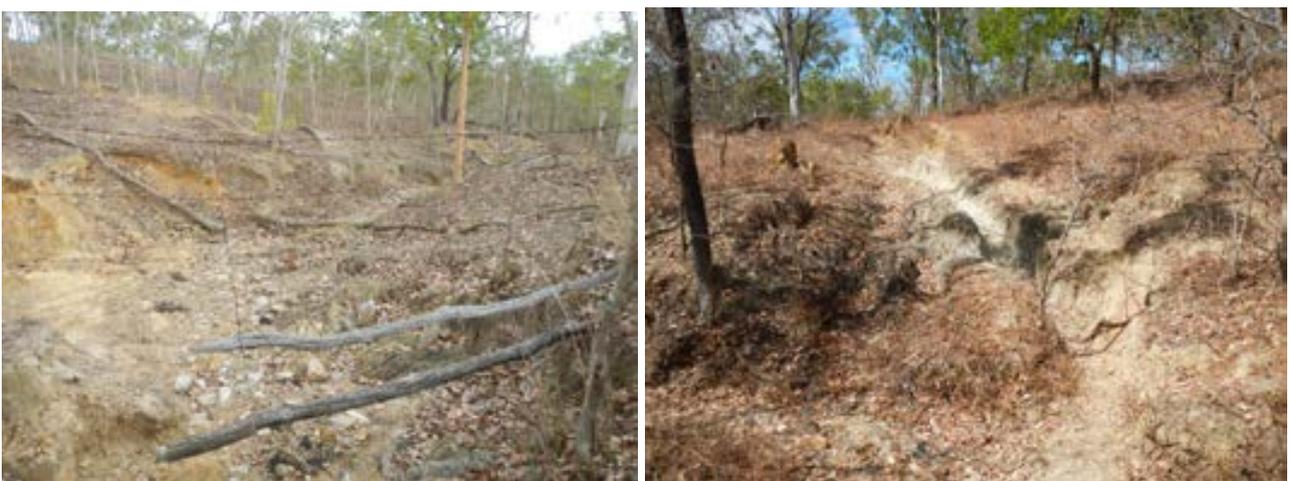
Figure 23 Fence-line, rill and gully erosion at road and cattle pad crossings of creeks in the Hodgkinson Formation on Springvale Station (Source: Jeff Shellberg).

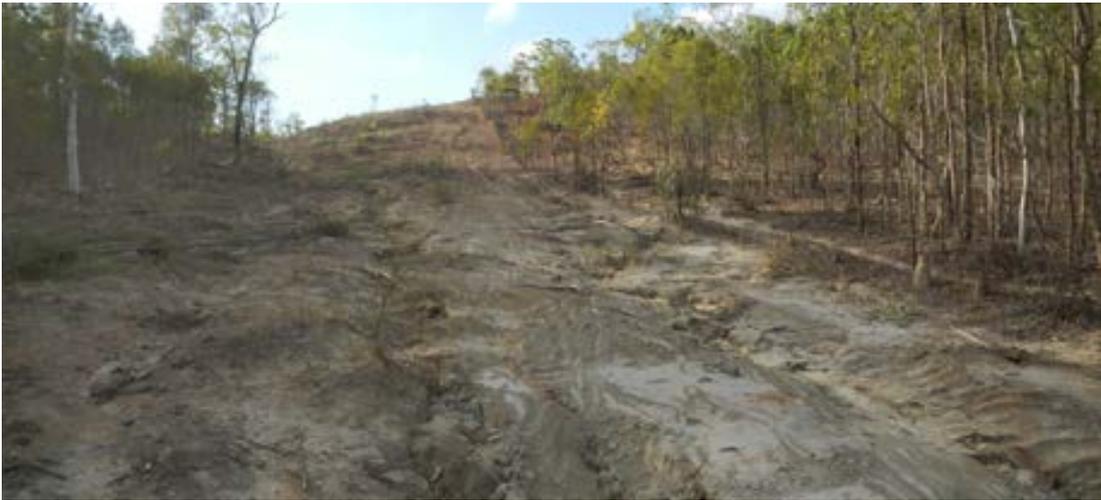
Figure 24 Fence-line rill and gully erosion from tree clearing (chaining) on the fence in the Hodgkinson Formation on Springvale Station (Source: Jeff Shellberg).

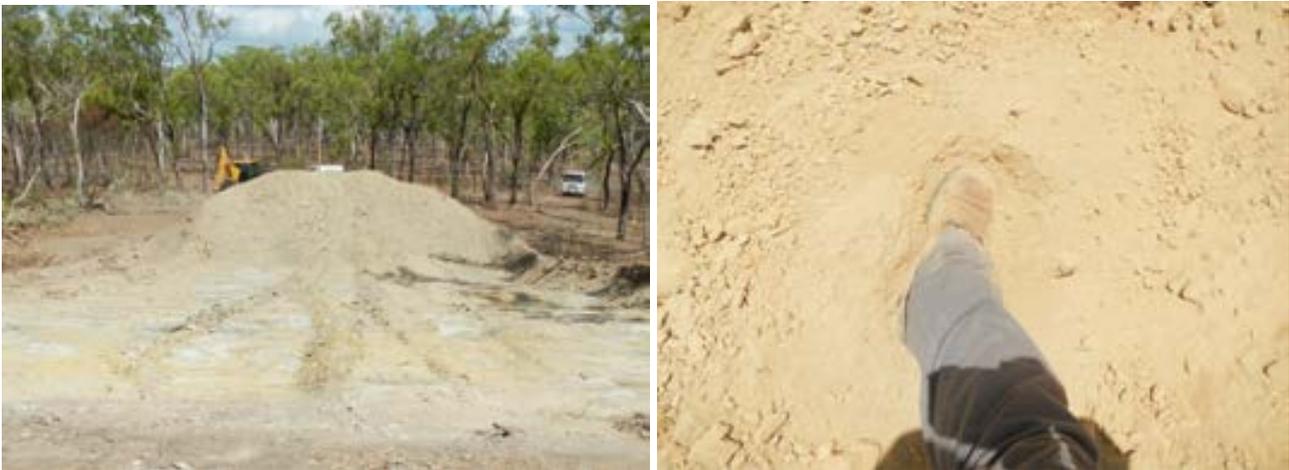
Figure 25 Meta-sedimentary rock (mudstone, siltstone, sandstone) from the Hodgkinson Formation is the only rock source locally available in remote areas for road erosion control, but most often contains high levels of fine matrix material that rock fragments are embedded within (Source: Jeff Shellberg).

In remote areas of Springvale Station, the mudstones, siltstones, sandstones of the Hodgkinson Formation are the only bedrock around and available for use in erosion control projects on roads, fence-lines, and gullies. This material, especially mudstones and siltstones of the Granite Normanby, produce a large amount of fine sediment on excavation, working and use along a road. Washing of matrix fine sediment from framework gravels by rainfall and overland flow is often the result (Figure 25; Shellberg and Brooks 2013). The use of this Hodgkinson Formation material needs to be assessed on a case-by-case basis to avoid collateral damage and unintended consequences. Where clean rock is required for road base or gully stabilisation, the use of a screening plant at a suitable quarry site could provide a cleaner local resource. In other situations where wash of matrix fine sediment from framework gravels is tolerable, this material could be used for slope stabilization where the fine grained matrix can support plant growth below the residual stone lag. In areas where arenite (quartz sandstone) from the Hodgkinson Formation has been used to cap battered gully slopes, the slopes have stayed intact and modestly vegetated despite ongoing sheet erosion (Figure 26). Siltstone and mudstone may perform differently.

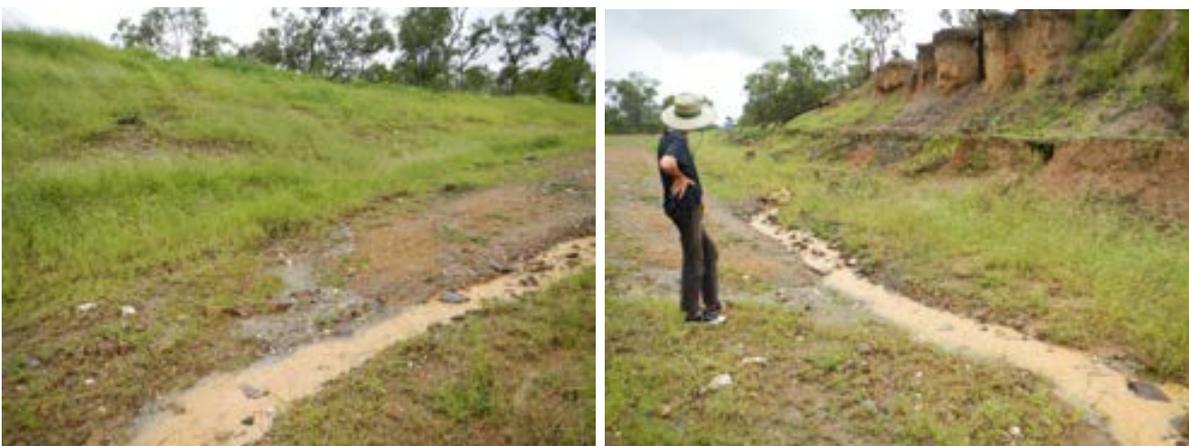
Figure 26 Example of a battered road cut (left, old West Normanby bridge approach) that was capped with arenite (quartz sandstone from the Hodgkinson Formation) around 10 years ago. The slope has modestly revegetated with weeds and clear water emerges from this slope compared with the sediment laden water derived from the untreated bank on the opposite side of the road (right) (Source: Jeff Shellberg (left) John Spencer (right)).

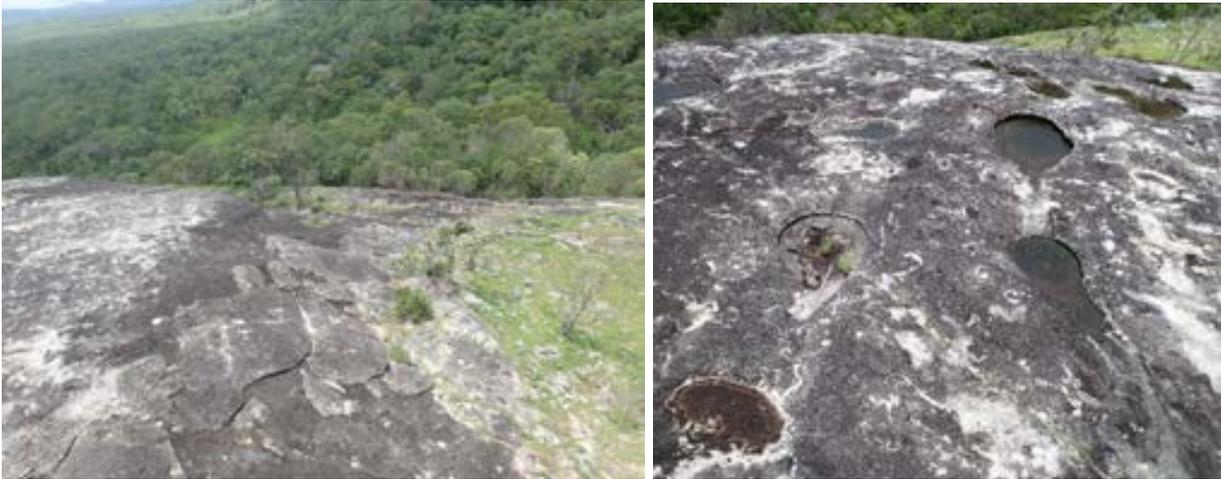
Figure 28 Granite outcrops and boulders on Mt Pike Formation on Springvale Station. Note outwash plain on footslope below (Source: Jeff Shellberg).

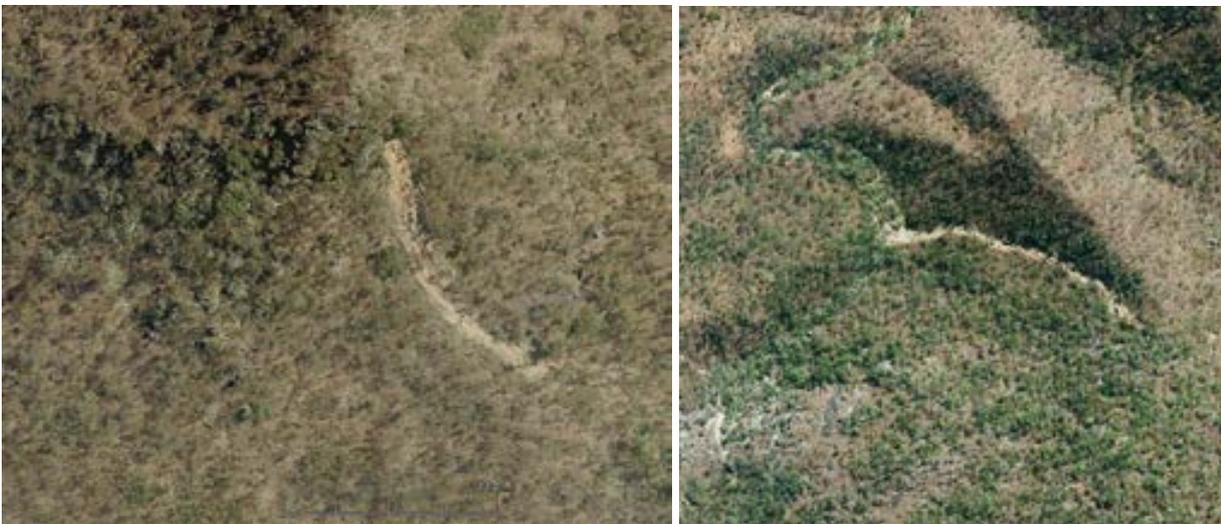
Figure 29 Landslide debris flows on steep slopes of Mt Pike Granite Formation on Springvale Station (left - 15.966751; 144.987256; right -15.970356; 144.977313) (Source: Jeff Shellberg).

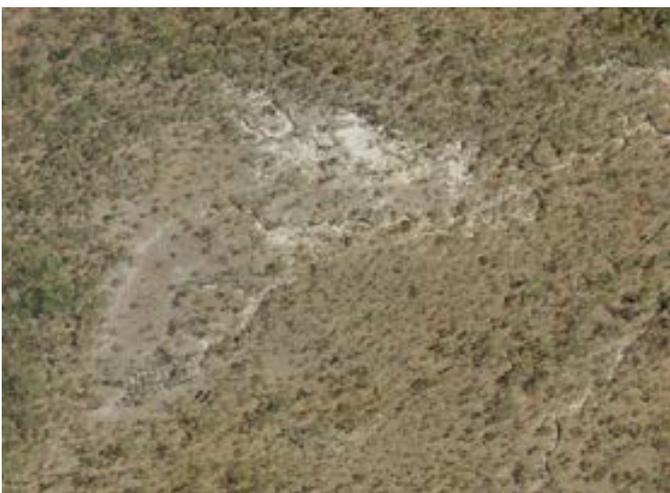
Figure 30 Colluvial footslope outwash plain below Granite outcrops on Springvale Station (Source: Jeff Shellberg).

Most erosion associated with the granite appears to be along the colluvial and alluvial footslopes and outwash plains of the granite mountains. On these footslopes, the sodic duplex soils derived from granite are highly prone to sheet, rill and especially gully erosion. Excess water runoff from the impervious granite can prove the energy for erosion, while reduced vegetation cover and cattle disturbance on granite derived soils can destabilise outwash material that has been building up at footslopes for tens of thousands of years. Most often the gully erosion is concentrated into linear colluvial deposits along drainage channels, but also can form into larger gully complexes of a mixture of colluvium and alluvium (Figure 30).

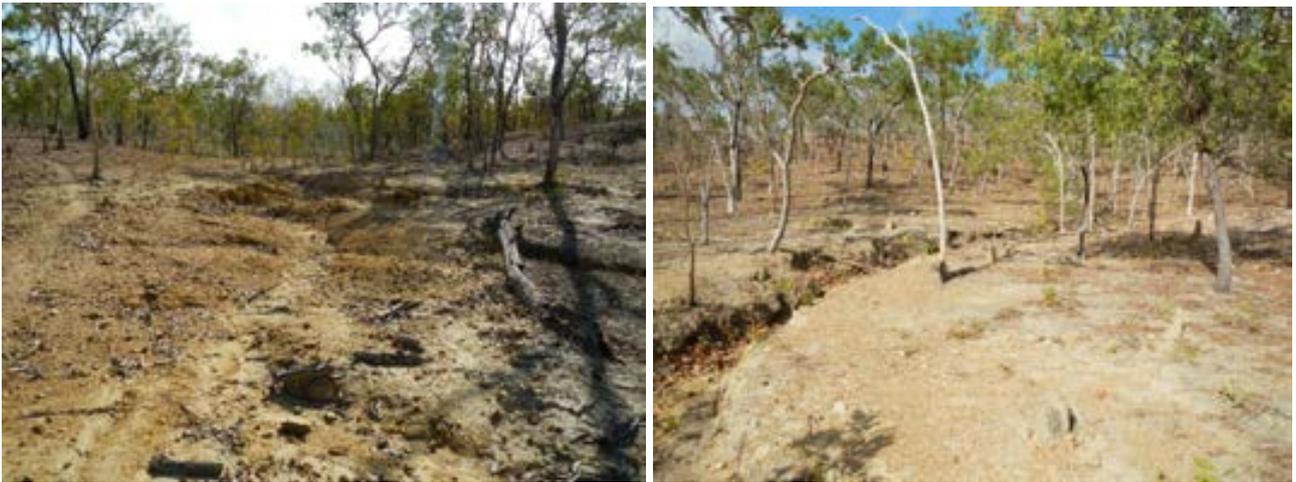
Figure 31 Colluvial gully, rill and sheet erosion at footslopes of bedrock hillslopes on Springvale Station (Source: Jeff Shellberg).

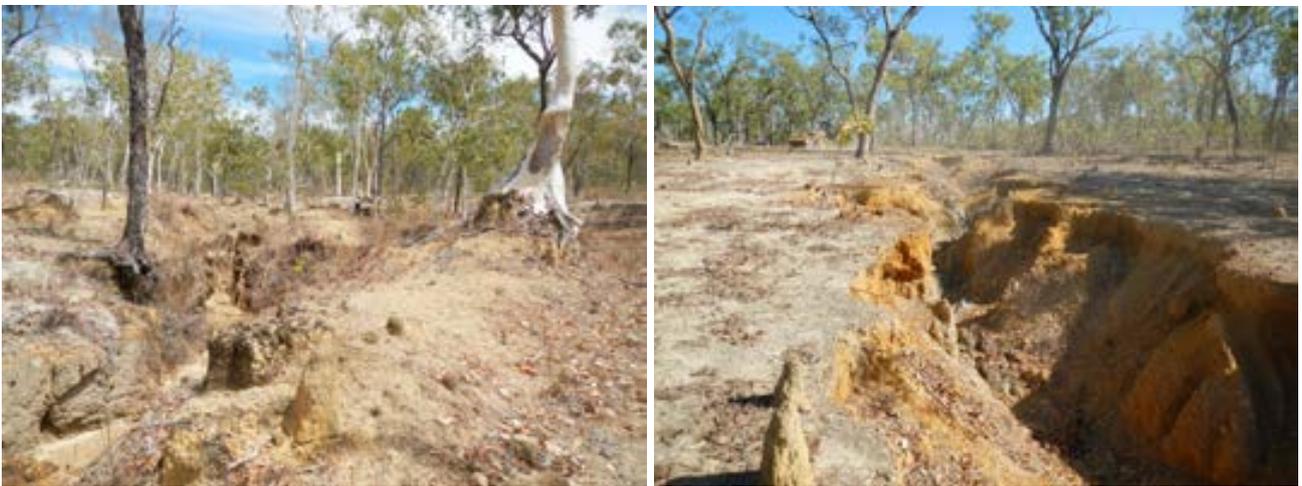
Figure 32 Colluvial gully erosion into outwash plains near footslopes on Springvale Station (Source: Jeff Shellberg).

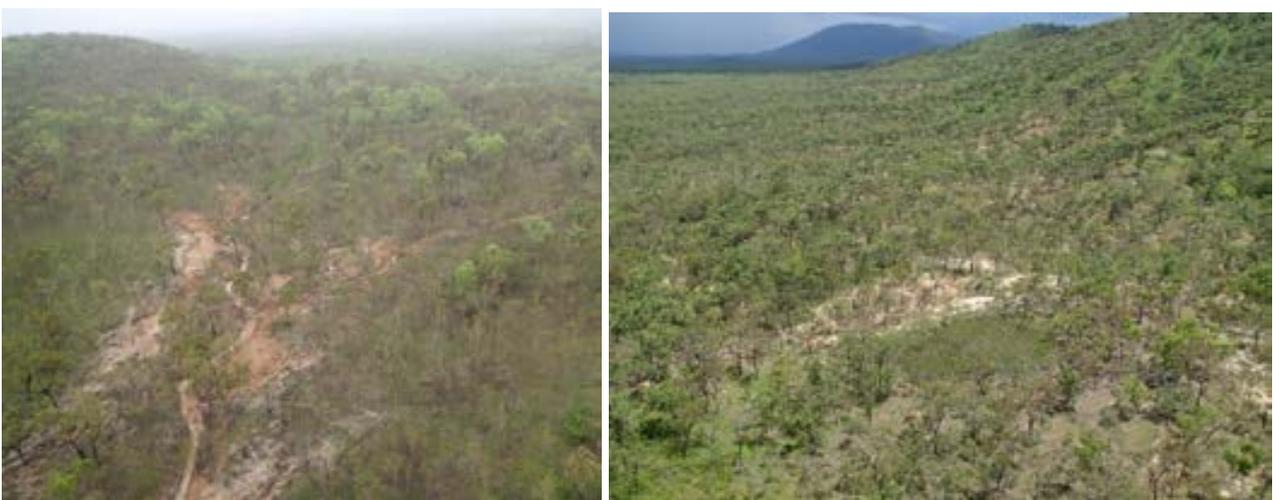
Figure 33 Colluvial gully, rill and sheet erosion on colluvial outwash plains near the footslopes of bedrock hillslopes on Springvale Station (Source: Jeff Shellberg).

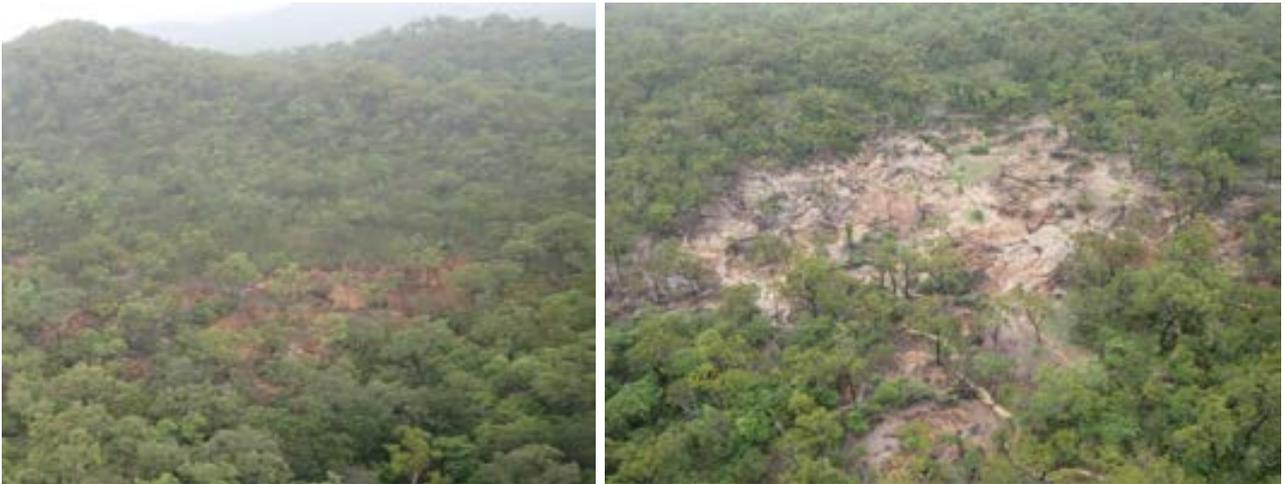
Figure 34 Colluvial gully erosion at the interface of hillslope/colluvium/alluvium on Springvale Station (Source: Jeff Shellberg).

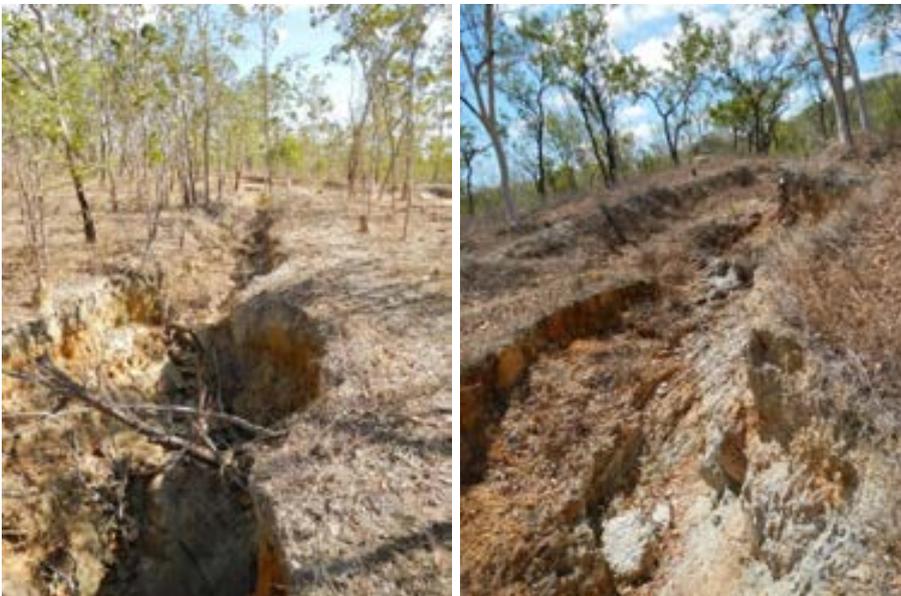
Figure 35 Colluvial gully erosion from road water diversion and a fence-line machine cut on Springvale Station (Source: Jeff Shellberg).

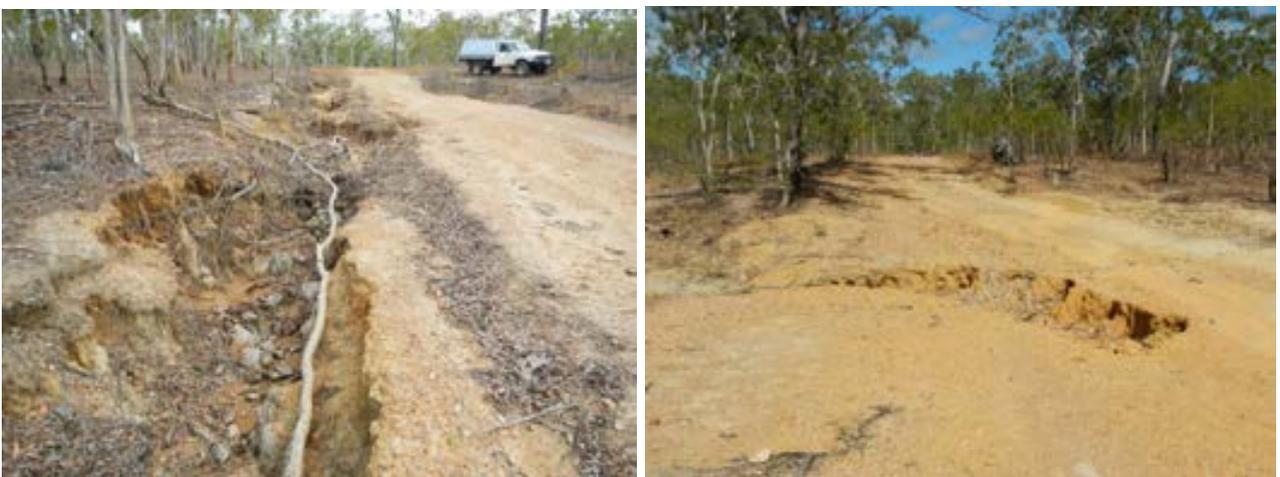
Figure 36 Road colluvial gully erosion on Springvale Station (Source: Jeff Shellberg).

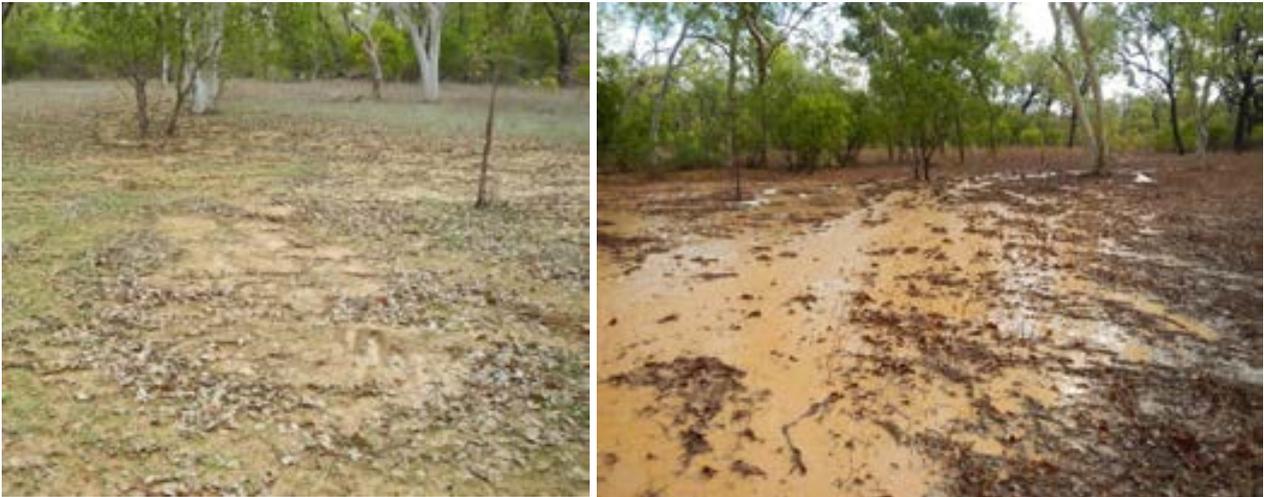
Figure 37 Sheet flow erosion from alluvial flats on Springvale Station (Source: Jeff Shellberg).

Sheet erosion is common on the undulating floodplains (Figure 37), as well as terrace and river banks, the heads of gullied terrain (Figure 38; Figure 39). The fine nature (clay and silt) and high sodicity of these massive soils limits their porosity and infiltration capacity, and enhances surface water runoff. Sheet flow erosion is also very important in rounded “pre-European” alluvial hollows and alluvial terrace slopes (i.e. prior slower phases of drainage network development), where earlier rounded sub-catchment forms and tributaries drain water from terraces toward incised rivers (Figure 40; Shellberg et al. 2016a; Brooks et al. 2013). These earlier drainage forms were dominated by *diffusive* sediment transport processes where rain and sheet erosion detached and moved soil particles and peds multiple short distances downslope (i.e., a form of soil creep) resulting in rounded convex slope forms developed over longer periods of geologic time (e.g., Fernandes and Dietrich 1997; Pelletier 2008). In contrast after gully channel incision into these incipiently unstable rounded landforms (Shellberg et al. 2016a), *advective* sediment transport processes began to dominate where dispersive sub-soil particles are rapidly exported (advected by fluvial transport) out of gully complexes following mass failure, scarp retreat, and side-wall failure as a result of deep rilling or gully channel incision (Pelletier 2008; Shellberg, unpublished data and manuscript) (Figure 41; Figure 42).

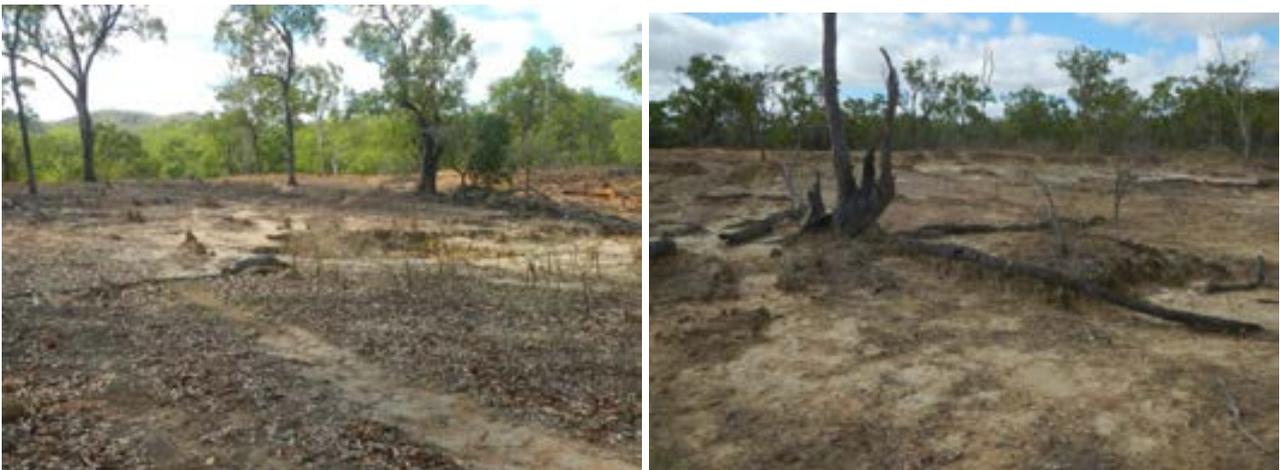
Figure 38 Sheet flow erosion, soil scalding, and soil stripping above alluvial gully complexes on Springvale Station (Source: Jeff Shellberg).

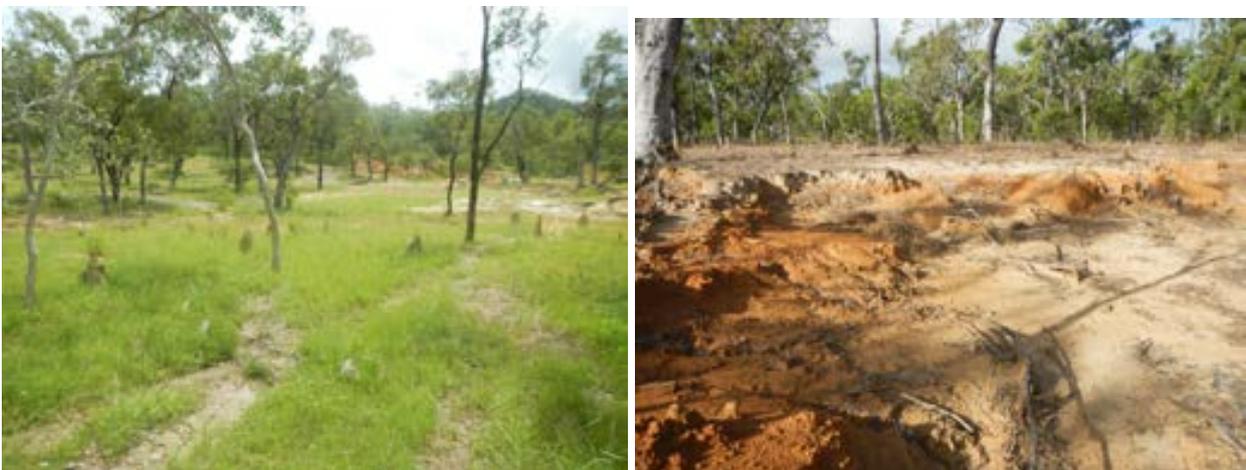
Figure 39 Sheet flow erosion, cattle pad erosion, and shallow gully erosion at heads of alluvial gully complexes on Springvale Station (Source: Jeff Shellberg).

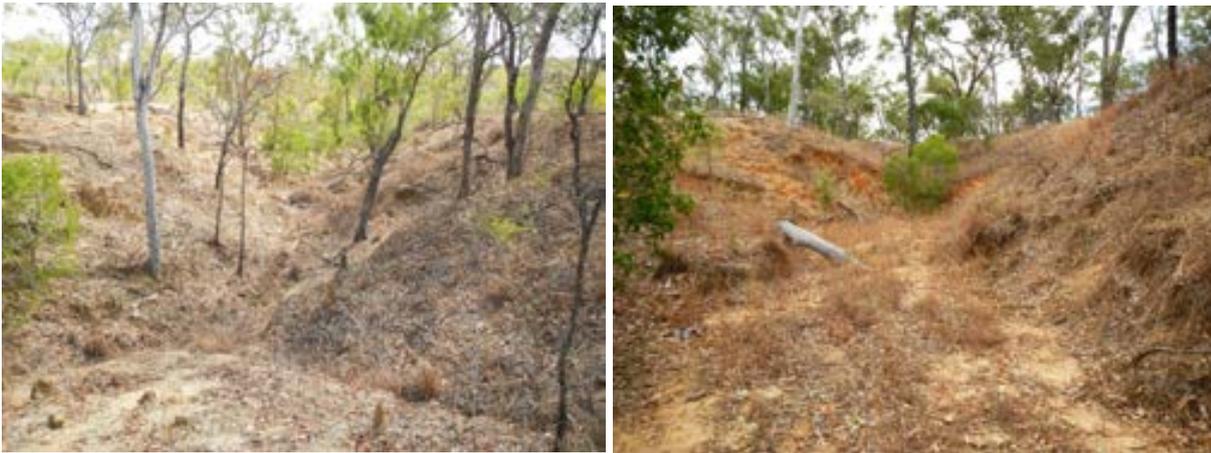
Figure 40 Pre-European alluvial drainage forms (rounded hollows and drainage networks on terrace banks) that are beginning to be stripped of soil, scarped, and incised by gullies 'in situ' to the pre-European landform (note intact trees growing on the original slope form dominated by diffusive erosion) (Source: Jeff Shellberg).

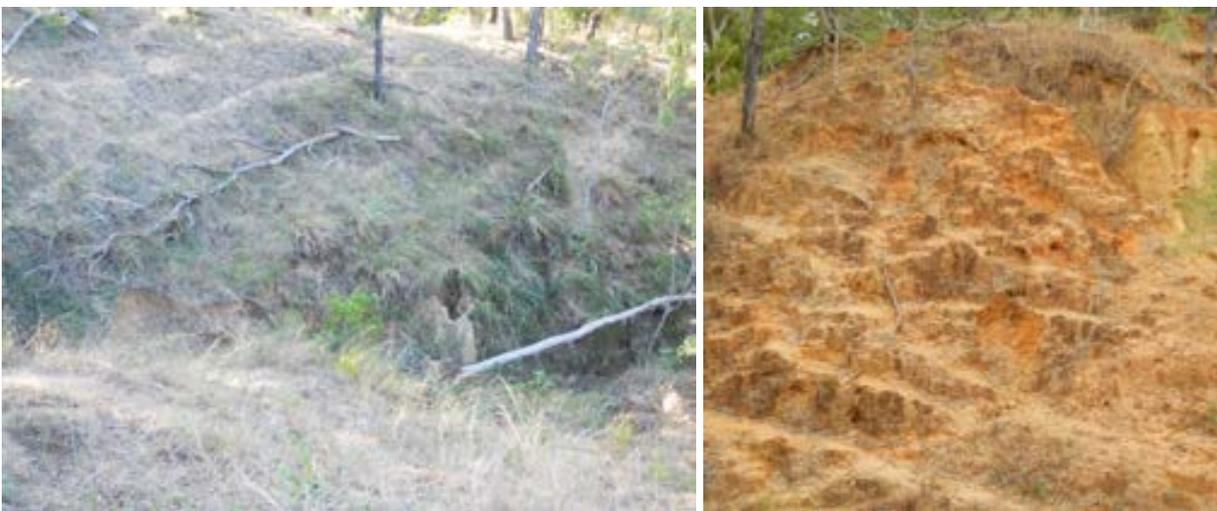
Figure 41 Pre-European alluvial gully hollow and slope forms that are being dissected and rejuvenated by gully incision (left) that more effectively advects (exports) sediment, in addition to slope degradation by rilling, sheet erosion, animal terracettes (cattle and wallaby), and slumping (Source: Jeff Shellberg).
