Technical Report to the Springvale Station Erosion Management Plan

Cape York Natural Resource Management 2017

The Springvale Station Erosion Management Plan presents a summary of the recommended implementation approaches for reducing sediment loss from Springvale Station (www.qld.gov.au/environment/coasts-waterways/catchment-management/springvale-station).

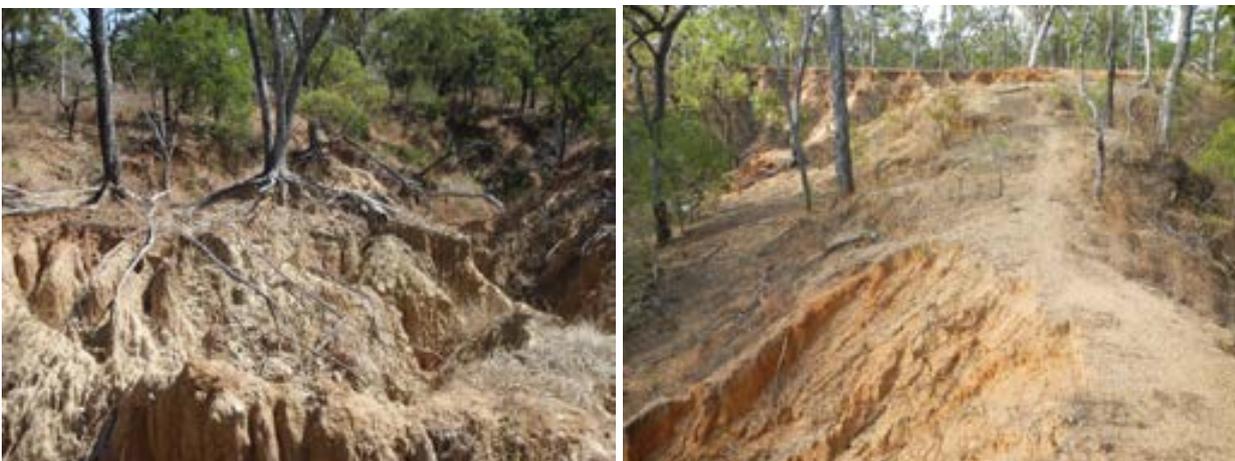
Figure 42 Scarped and incised alluvial gully complexes in situ, with traces of the pre-European drainage forms (note trees on rounded convex slopes) on Springvale Station (Source: Jeff Shellberg).

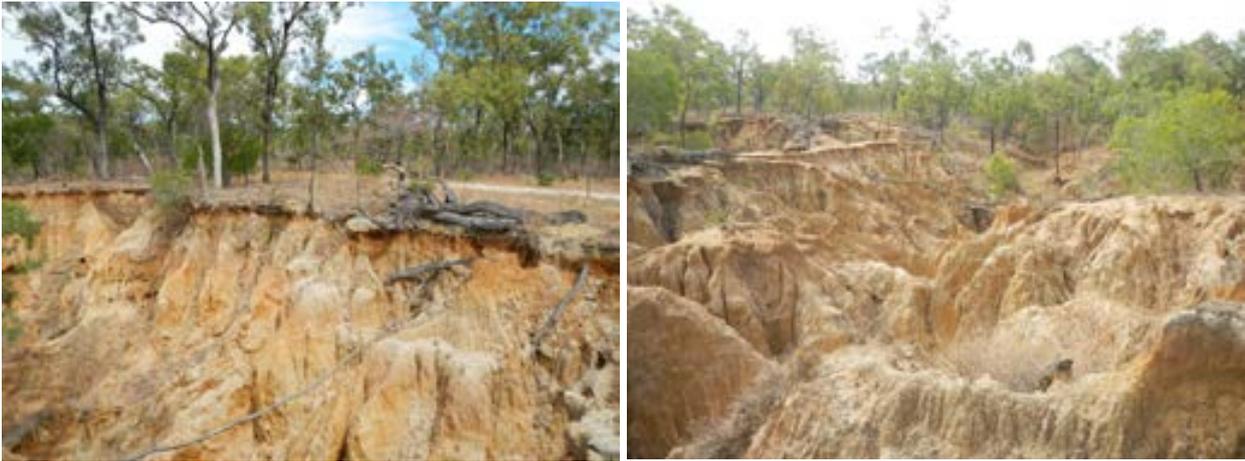
Figure 43 Mature and fully scarped alluvial gully complexes destabilized from downstream gully channel incision and major scarp retreat on Springvale Station (Source: Jeff Shellberg).

Disturbance of alluvial hillslope catchments – either through natural processes such as intense rainfall, fire, and river incision – or human land use such as grazing, loss of grass cover, cattle pads, roads and fences, and tree clearing – can increase water runoff, reduce vegetation and organic soil cohesion, concentrate water into rills, and promote downstream channel incision and gullying (AGSO 1995; Shellberg 2011; Shellberg and Brooks 2013; Shellberg et al. 2016a). Channel incision associated with lower river base levels and disturbance of adjacent alluvial soils, high banks and terrace slopes often promotes new rill and gully erosion into older rounded “pre-European” alluvial drainage forms (Figure 40; Figure 41). Over time with ongoing disturbance and growth of gully headcuts inset within older, rounded, alluvial slope catchments, these alluvial gully catchments erode *in situ* into the sharp gully forms seen today in the upper Normanby catchment (Figure 42; Shellberg, unpublished data and manuscript). Then over longer periods of time and gully evolution these gullies can erode further back into alluvial terrace slopes, and coalesce with neighboring gullies to form major scarp fronts of mature gully complexes (Figure 43).

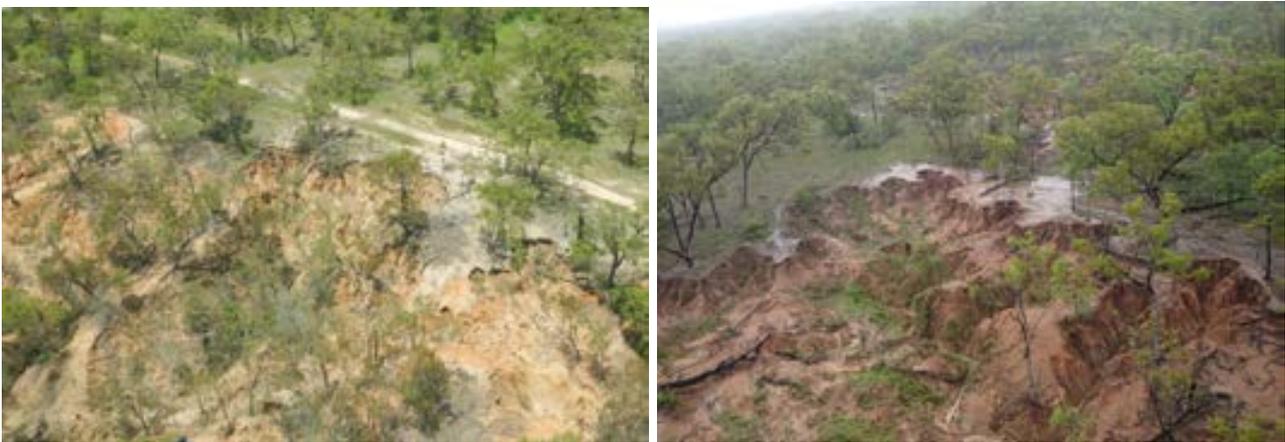
Figure 44 Mature alluvial gully complexes where much of the pre-European drainage forms have been eroded by gullies on Springvale Station (Source: Jeff Shellberg).

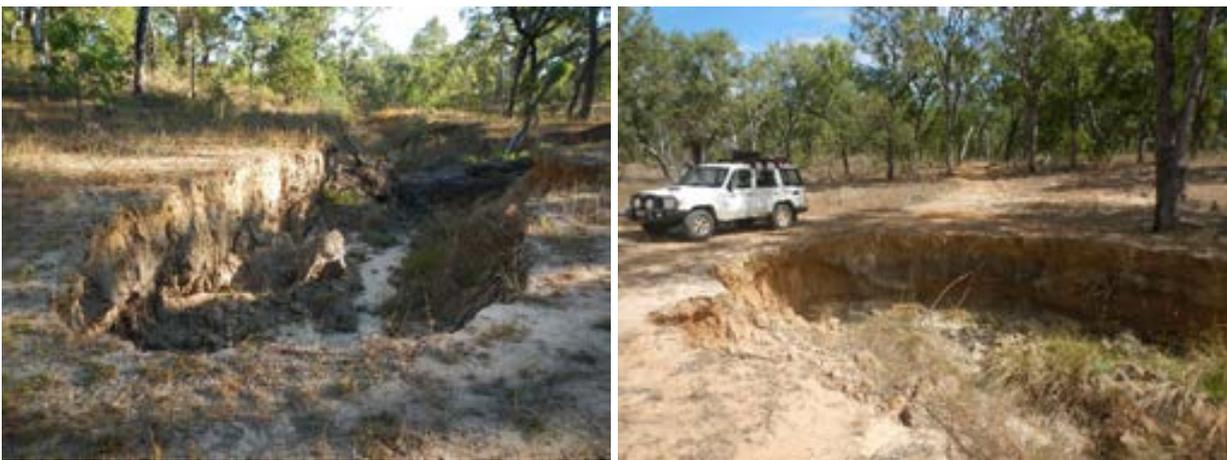
Figure 45 Young linear gully headcuts advancing into uneroded alluvial hollows (channel-less valleys) on Springvale Station (Source: Jeff Shellberg).

In alluvial terrace situations with wider un-eroded alluvial hollows and paleo-channels, linear gully erosion headcuts can advance up valley and consume large areas that were virtually free of gully erosion pre-European settlement (Figure 45; Figure 46). These rapidly advancing gullies are more akin to alluvial gullies in the adjacent Mitchell River catchment (Brooks et al. 2009; Shellberg 2011; Shellberg et al. 2016a). Over time, these linear headcuts can lengthen and widen until the entire alluvial hollow or paleo-channel catchment is consumed by deep sharp gully faces. Multiple stages of gully evolution and erosion processes, forms and types often can be seen in areas of widespread and complex alluvial gully erosion (Figure 47).

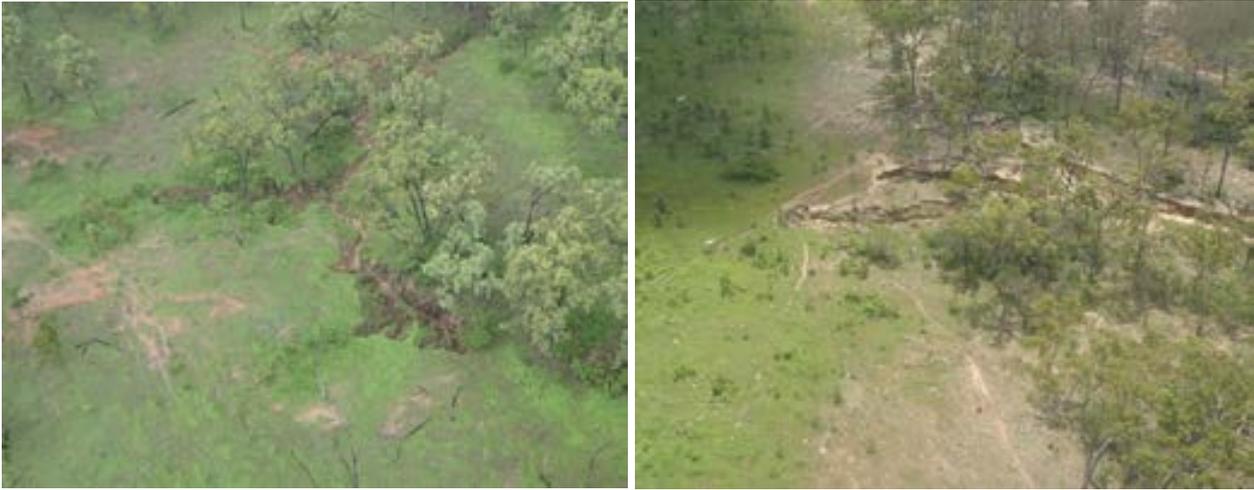
Figure 46 Young linear gully headcuts advancing into uneroded alluvial terrace flats on Springvale Station (Source: Jeff Shellberg).

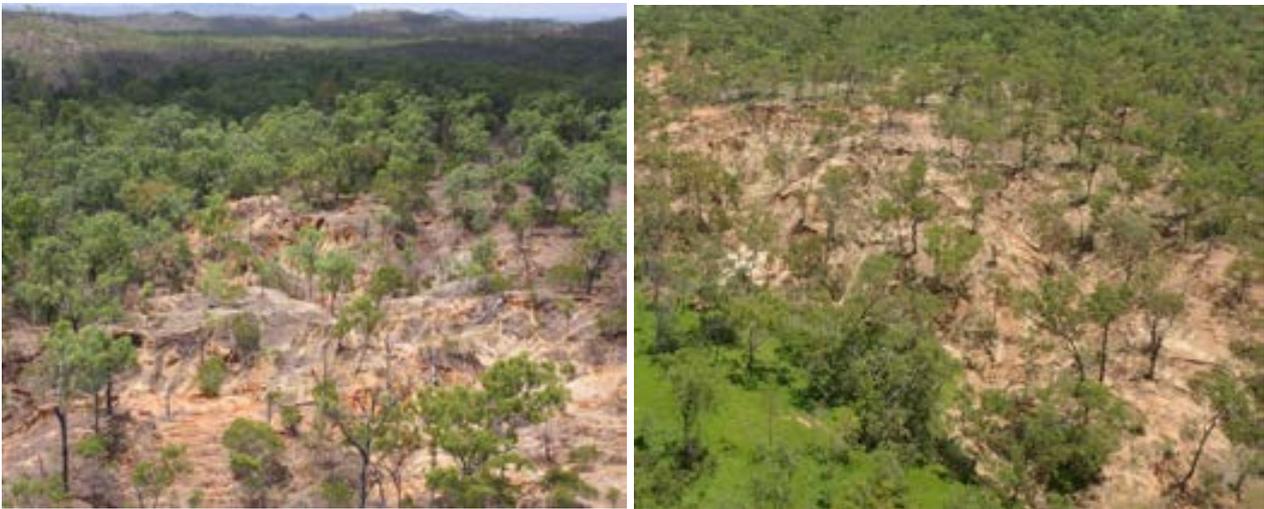
Figure 47 Widespread alluvial gully complexes on Springvale Station with mixed stages of gully evolution and vegetation cover (Source: Jeff Shellberg).

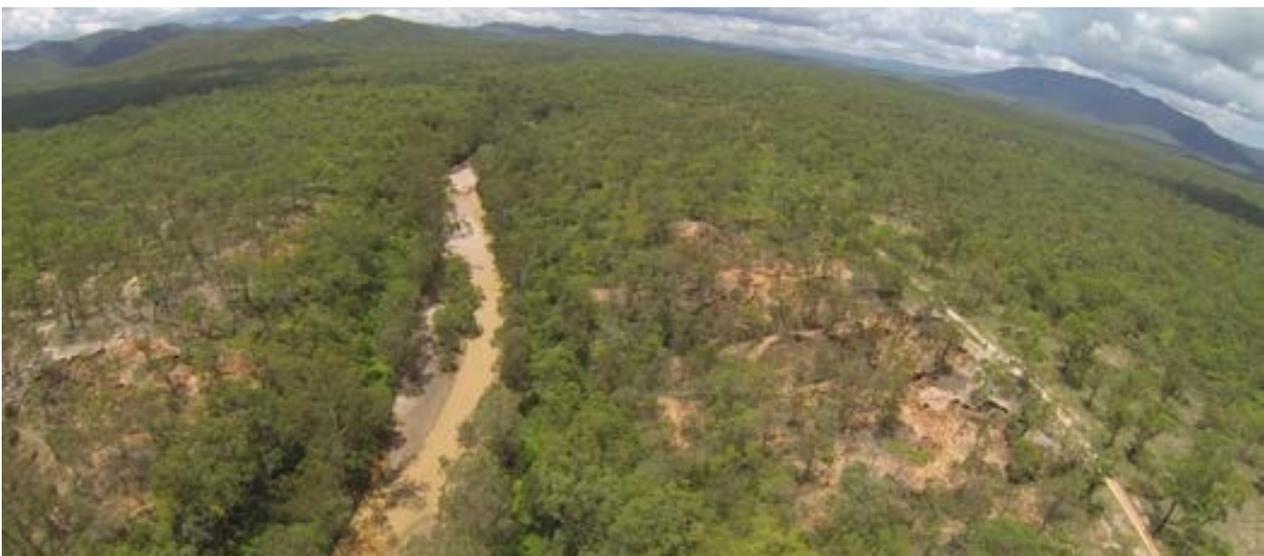
Figure 48 Alluvial gully complexes on both banks of the Granite Normanby River at Springvale Station (Source: Jeff Shellberg).

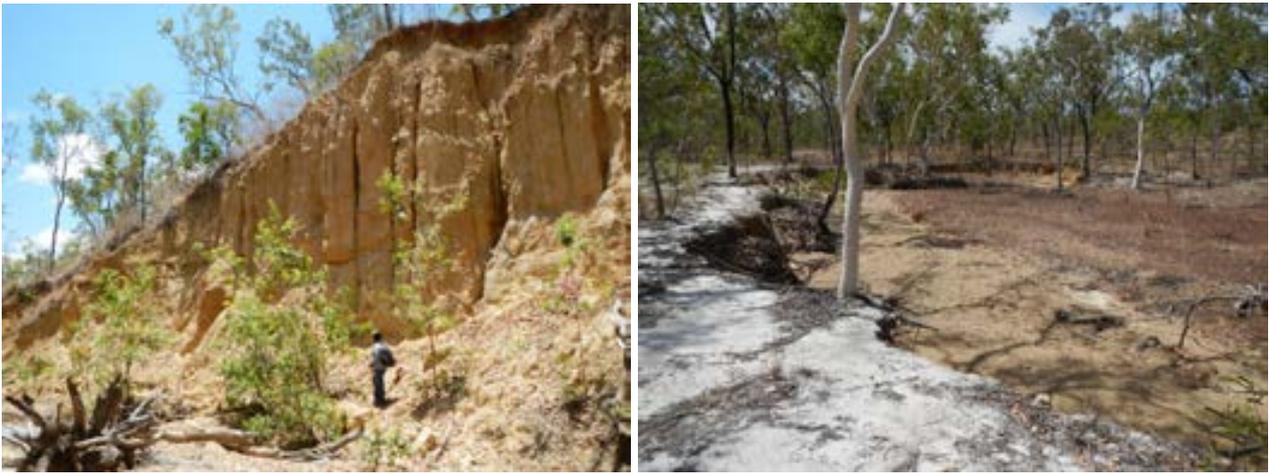
Figure 49 Bank erosion in large (left) and small (right) alluvial channels at Springvale Station (Source: Jeff Shellberg).

Bank erosion into alluvial soils of incised rivers and tributary creeks is also common along East, Granite, and West Normanby Rivers (Figure 49). High banks eroding into Pleistocene alluvium (circa 30,000 years) look dramatic in the landscape, but are often somewhat protected at their toe by indurated (hardened) alluvium at depth. This type of bank erosion is largely natural along the incised rivers, where vegetation has only localized influence on erosion of these cut banks during major (such as casuarina trees at their toe). In contrast, alluvial terrace river banks between steep meander bends (e.g., Figure 48) are vulnerable to loss of vegetation cover from cattle grazing, and are prone to enhanced gully erosion and incision partially fueled by flood backwater and drawdown erosion into the lower ends of small tributary catchments (e.g., Shellberg et al. 2013a). Bank erosion in smaller tributaries can be accelerated by enhanced water runoff from catchment disturbance, reduced vegetation cohesion of banks due to grazing, and waves of bedload sediment (sand) released from upstream gully erosion (Figure 49).

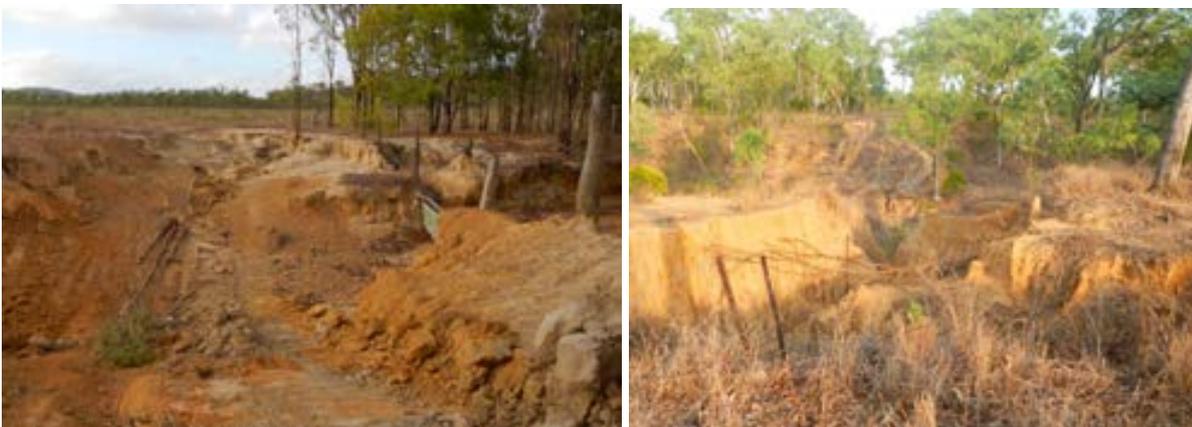
Figure 50 Fence-line erosion through alluvial soils at Springvale Station (Source: Jeff Shellberg).

Fence-lines were historically installed on Springvale Station in attempts to control cattle grazing on river frontage country. However, the machine and cattle disturbance along these fence-lines led to deep gully erosion where fence-lines cross small or large tributary banks and channels (Figure 50; Shellberg and Brooks 2013).

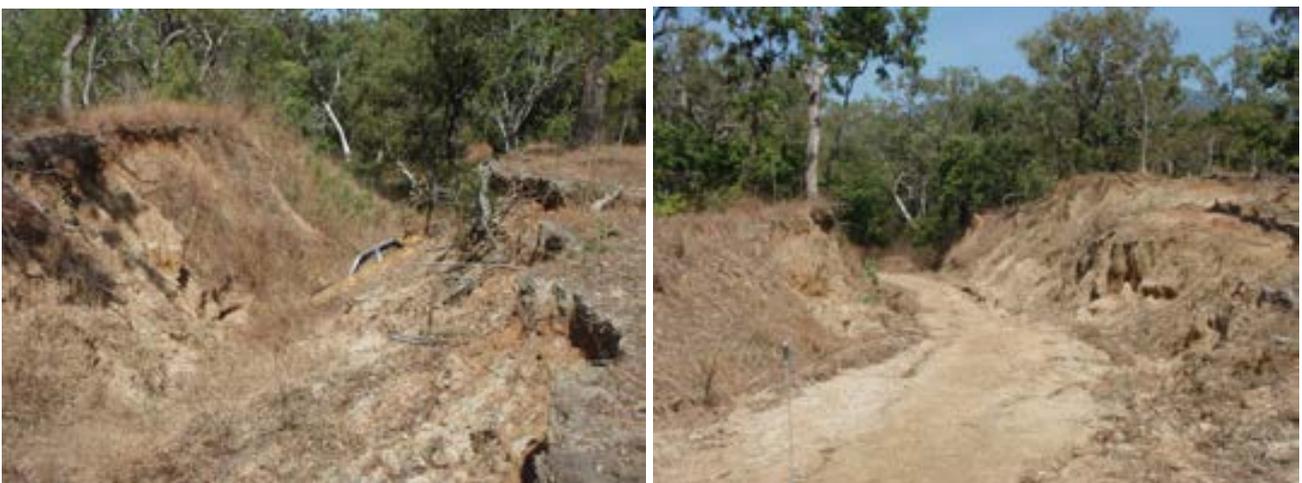
Figure 51 Road cut erosion and resultant alluvial gully erosion at Springvale Station (Source: Jeff Shellberg).

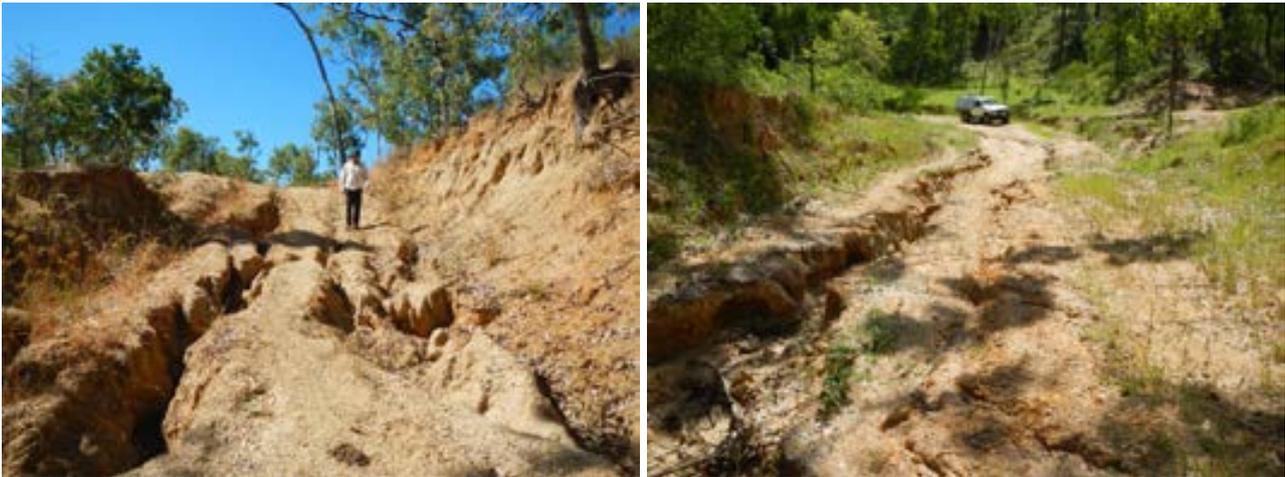
Figure 52 Road cut erosion in alluvium at Springvale Station (Source: Jeff Shellberg).

Road and track erosion along alluvial floodplain soils is very severe on Springvale Station (Figure 51; Figure 52; Figure 53; Figure 54; Figure 55). Road cuts over steep banks with bulldozers or along alluvial flats with graders often lead to major sheet, rill and gully erosion. Road location, use and maintenance often did not take into account the highly unstable nature of these sodic soils (AGSO 1995; Shellberg and Brooks 2013). Initial sheet erosion concentrated along road scraps and cuts funnels water off alluvial flats during heavy rain with little infiltration. This water concentrates at steep road sections and cuts rills. Over time and years, these rills can form deep gullies that make the road impassible. Band-aid measures are often implemented each year to grader or doze out problem sections to maintain access, but over years to decades this makes the erosion much worse. Eventually road choke points develop where road caused erosion is so severe that vehicles cannot pass by the gullies that were created or accelerated by the road (Figure 53; Figure 54; Figure 55). Major intervention is often needed to regain access through these choke points (Shellberg and Brooks 2013) but extreme caution and careful design are needed as more bulldozer work and exposing more sodic subsoils can often make the matters much worse. The precautionary principle and proper design are paramount.

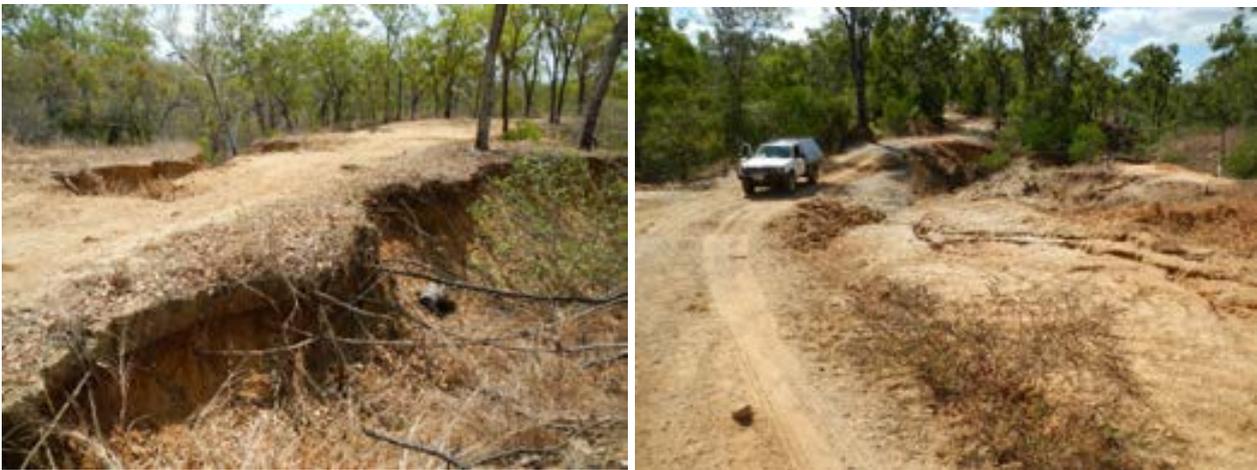
Figure 53 Road passage choke points through alluvial gully complexes at Springvale Station. Note the topsoil that is often lost from soil surface disturbance, enhancing erosion into sodic sub-soils (Source: Jeff Shellberg).

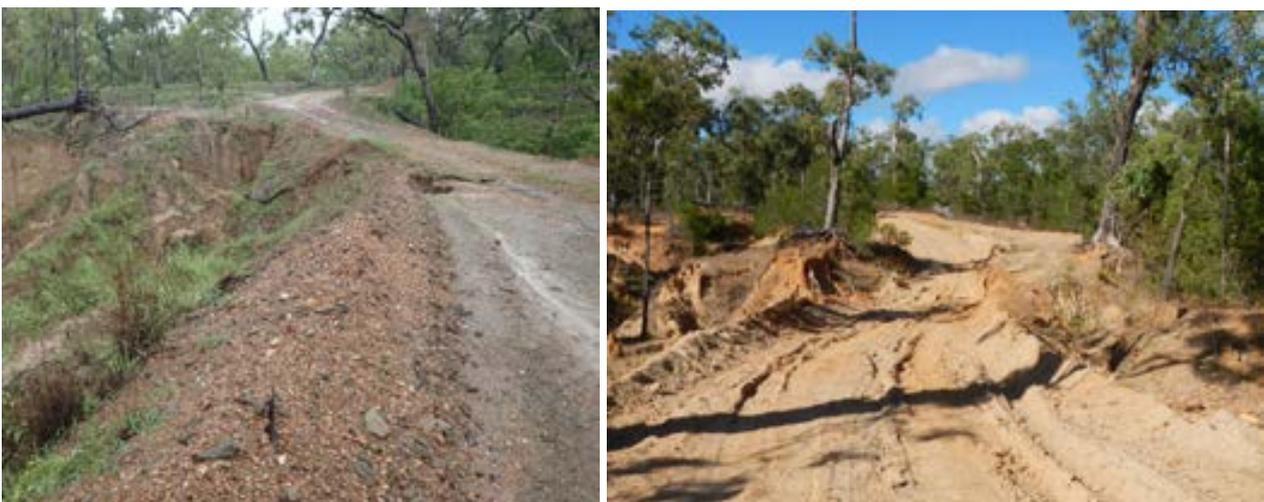
Figure 54 Road passage choke points through alluvial gully complexes at Springvale Station (Source: Jeff Shellberg).

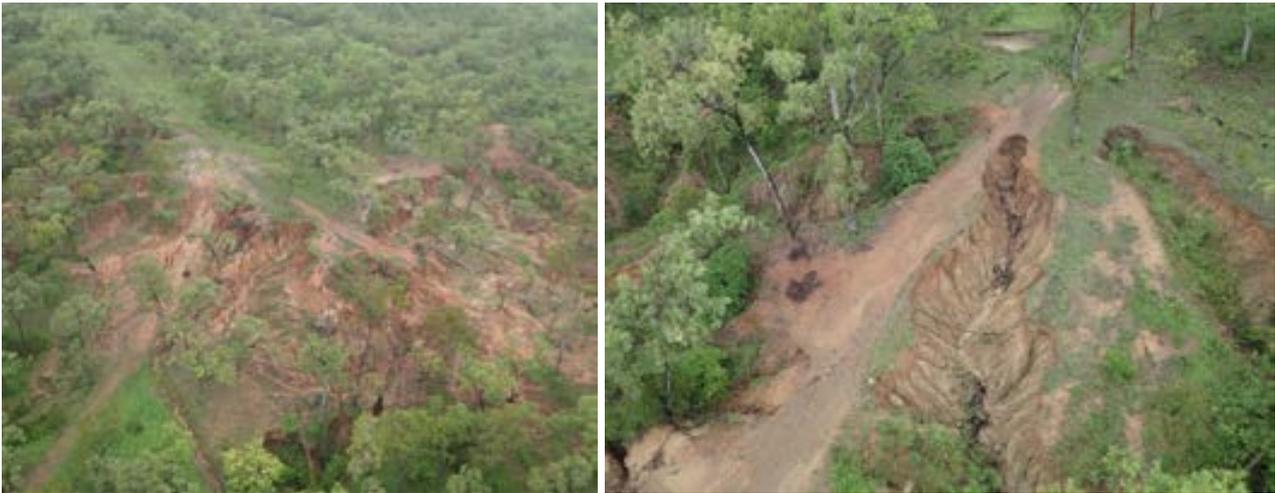
Figure 55 Road passage choke points through alluvial gully complexes at Springvale Station (note tyre on left) (Source: Jeff Shellberg).

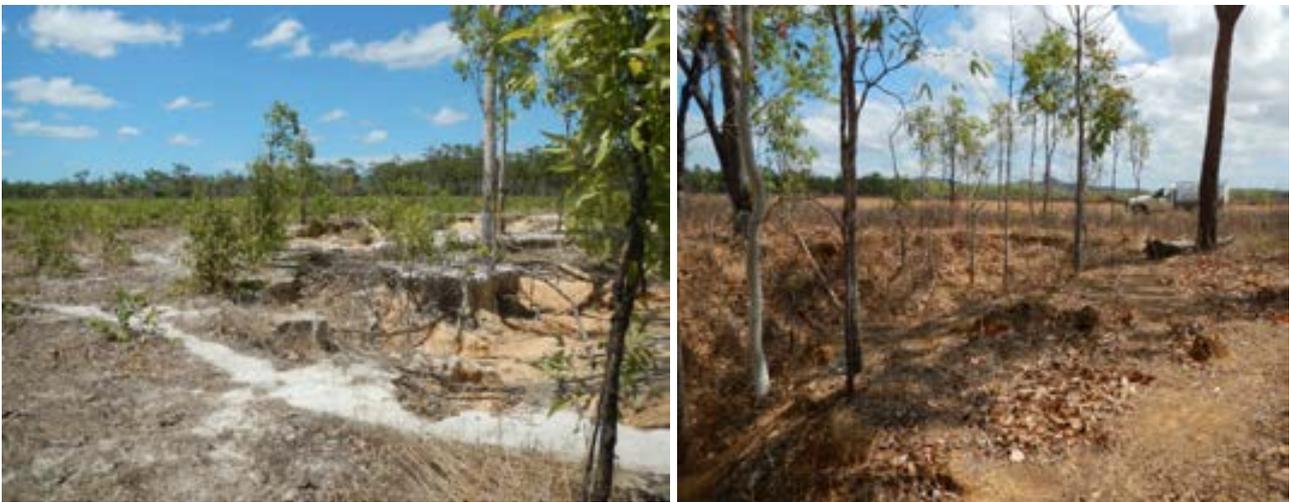
Figure 56 Alluvial gully erosion accelerated by tree clearing disturbance and excess water runoff at Springvale Station (Source: Jeff Shellberg).

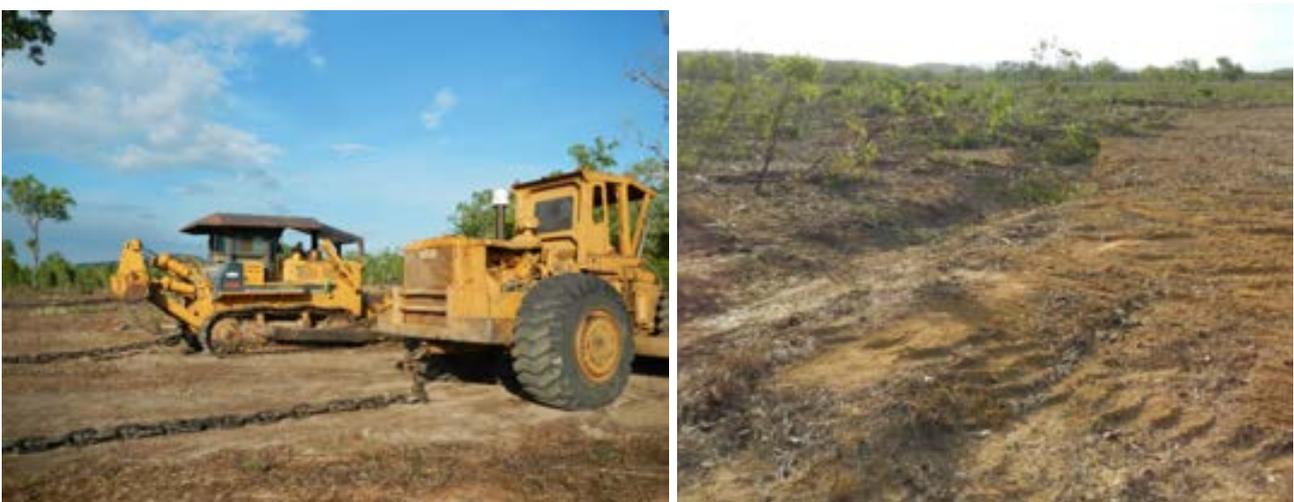
Figure 57 Tree clearing disturbance on sodic soils at Springvale Station affecting the fragile soil surface and ephemeral drainage channels on the floodplain prone to gully, and disrupting the natural tree-grass balance in native woodlands (Source: Jeff Shellberg).

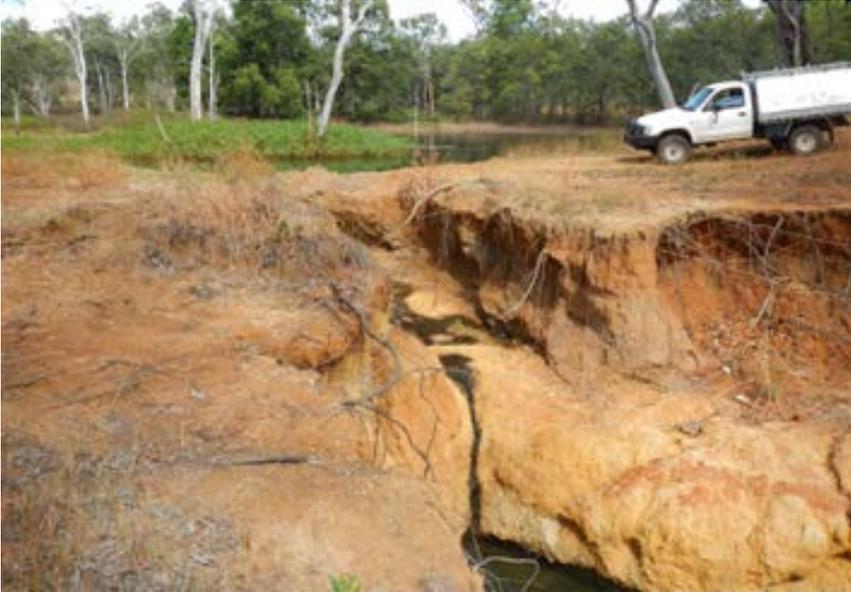
Figure 58 Potential for dam failure in areas where dams and bywash spillways are built on sodic soils and prone to alluvial gully erosion at Springvale Station (Source: Jeff Shellberg).

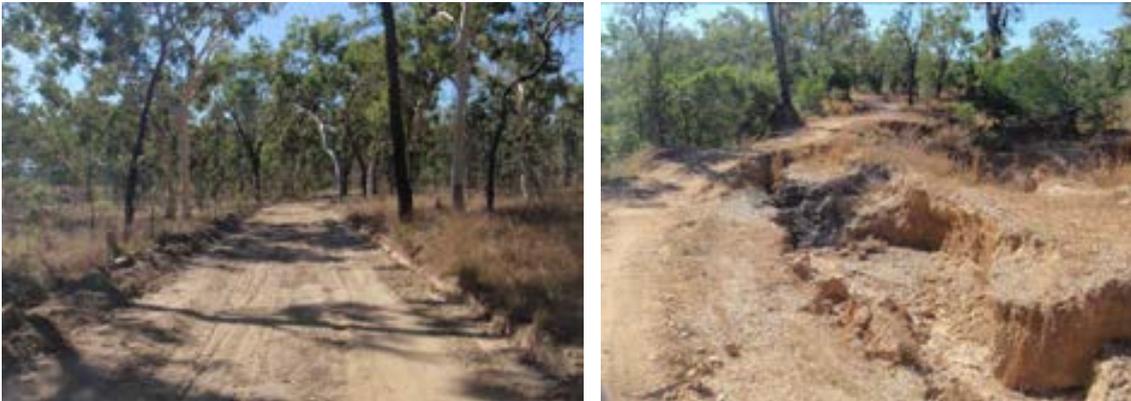
Figure 59 Examples of roads at Springvale Station graded repetitively on sodic soils that have concentrated water flow and caused deep gully erosion (Source: Jeff Shellberg).

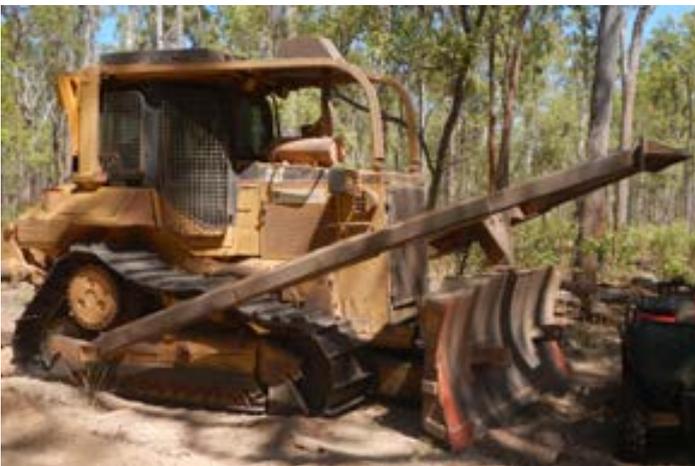
Figure 61 Typical road and fence maintenance equipment and erosion control styles used on Cape York will NOT be appropriate for addressing much road and fence erosion at Springvale Station on sensitive sodic soils, while minimising collateral damage and accelerated erosion (Source: Jeff Shellberg).

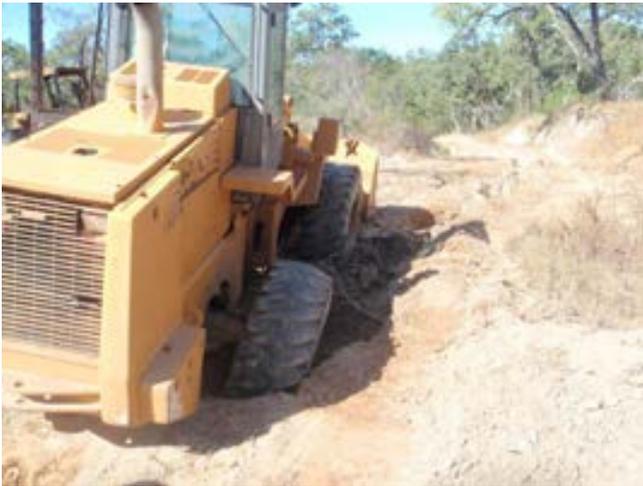
Figure 62 Deep gullies formed annually during the wet season - down steep road cuts in sodic soils - can be difficult to regrade and fill in using heavy machinery, with very short-term access benefits at Springvale Station (Source: Jeff Shellberg).

Most roads and fences in the alluvium and colluvial slopes geologic units (Priority Focus Sediment Management Areas outlined below) have been trapped in a vicious cycle of rapid annual clean-ups and machine re-grading to quickly get access to remote parts of the station for muster or delivering lick. Proper road maintenance budgets or plans have never been part of operations at Springvale Station. For example over the last 25 years, the road to ‘Keetings Paddock’ up the Granite Normanby Valley has been annually scraped with loaders or graders to rapidly get access for mustering (Figure 62). This occurred again in 2017. In easy cases, rills and gullies were smoothed over and filled with local borrow material of sodic soil, just to erode again the next wet season. In the larger more difficult cases, erosion problem areas were either battered via earthworks or just bypassed with a new road once a section of road became impassable. Relocating roads after serious erosion often just moves the problem from one location to another creating cycles of degradation (Figure 63; Figure 101). This style of management without any Best Management Practices (BMPs) (Shellberg and Brooks 2013) has led to a legacy of erosion damage and backlog beyond repair in many situations. These represent Worst Management Practices (WMPs).

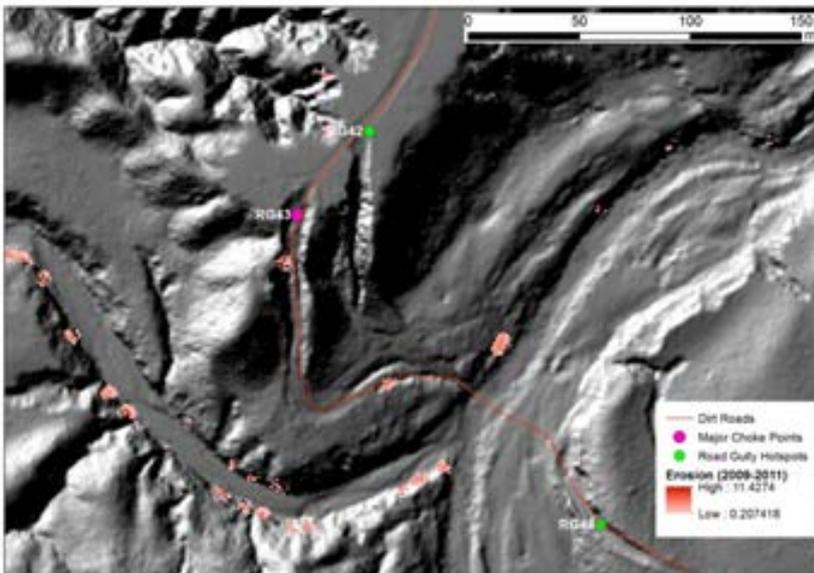
Figure 63 A road 'Choke Point' on the Granite Normanby road where deep gully erosion has restricted road access and forced machine operators to relocate the road nearby, creating the same situation again and perpetuating erosion cycles (Source: Jeff Shellberg).

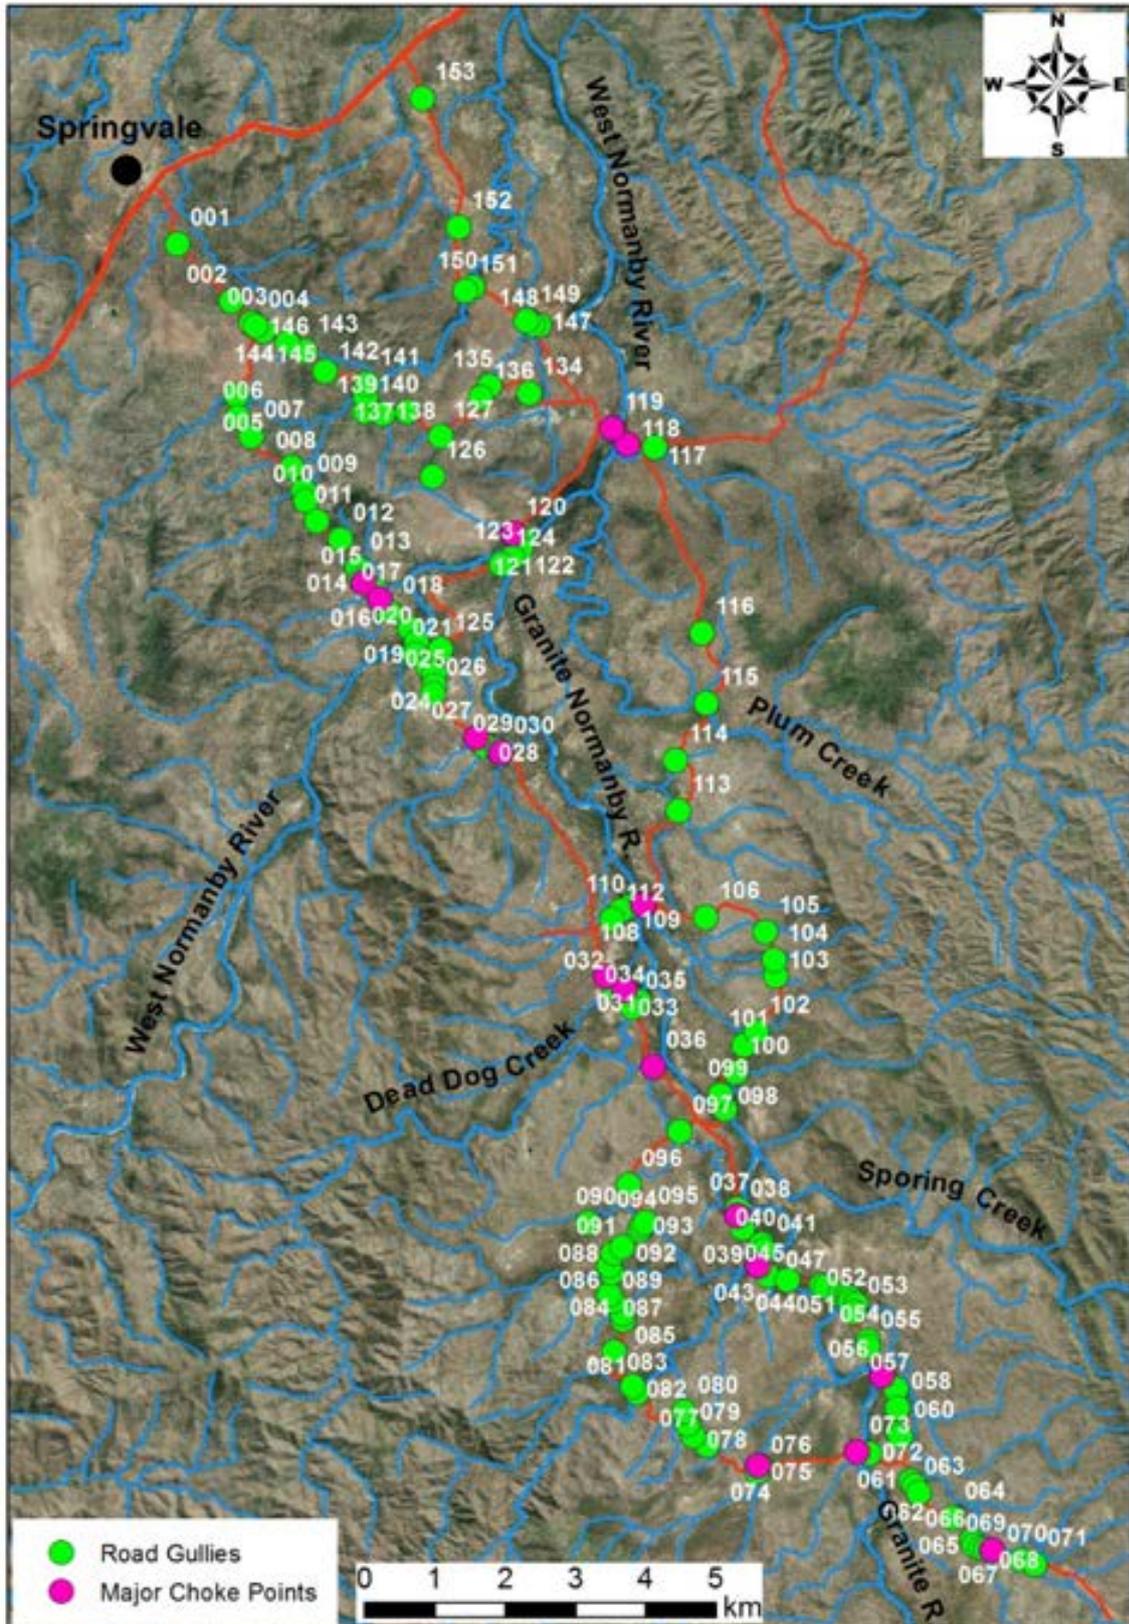
Figure 64 'Road Gullies' caused or accelerated by road construction and use along the southern half of Springvale Station between the Homestead and the 'Keetings Paddock'. Also included are road 'Choke Points' where gully erosion is so severe that it almost completely restricts vehicle access without heavy machinery intervention with appropriate bioengineering and precautionary principles of erosion control (Source: Jeff Shellberg).

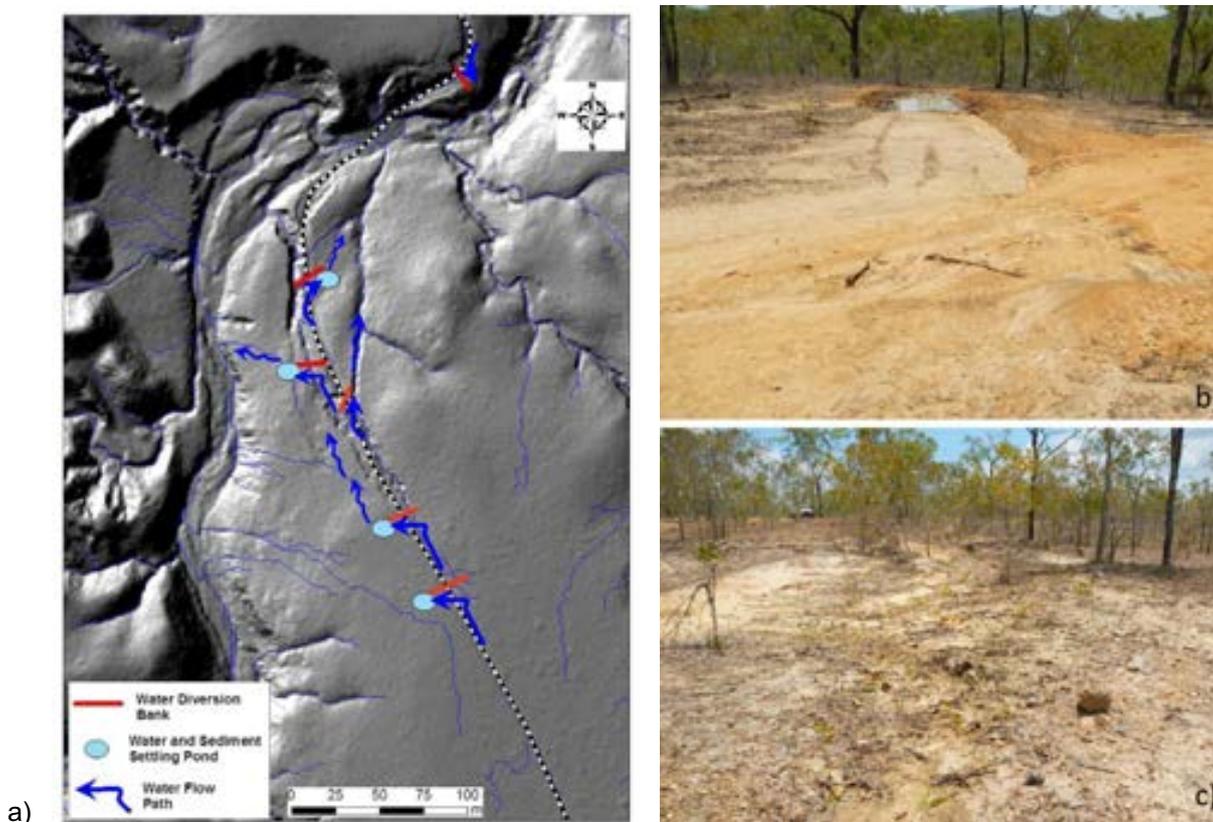
Figure 65 Improvements to road drainage at RG35 next to Dead Dog Creek a) mapped in plan view using a LiDAR hillshade with derived flow lines, with examples of b) a ‘whoa boy’ water diversion bank constructed from locally borrowed soil material excavated from a small settling pond, and c) an overland sheet flow path derived from the outlet of a settling pond eventually flowing into the creek (Source: Jeff Shellberg).

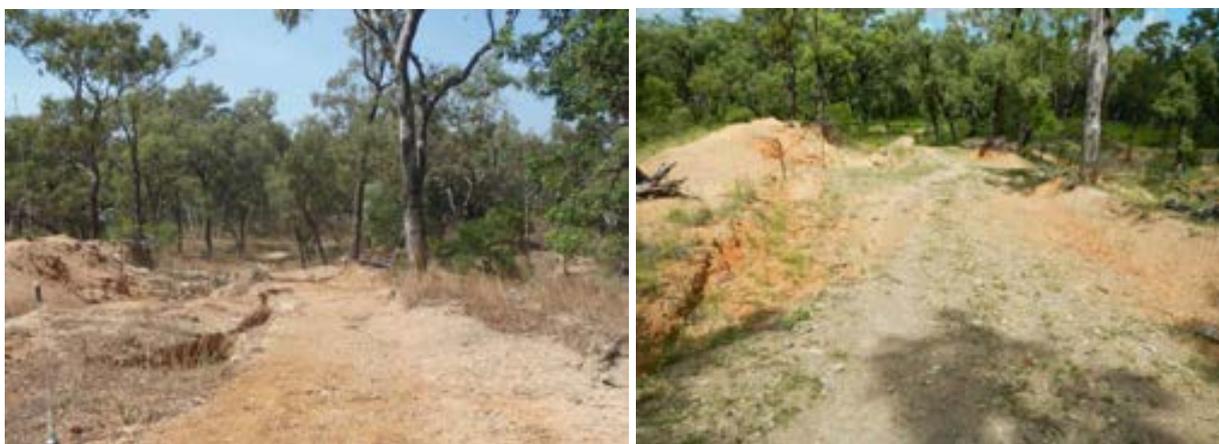
Figure 66 Erosion at road choke points at steep river banks in sodic soils can be reduced by installing frequent water diversion banks (whoa boys) and capping them with imported coarse rock (Source: Jeff Shellberg).

For major road 'Choke Point' sites (Figure 64), trials were conducted at 3 treatment and 1 control sites surveyed before and after with terrestrial LiDAR. These were the 'easiest of the bunch' of choke points. The control site had business as usual (annual grading end wet season), while the controls has combinations of water diversion banks, partial surface capping with rock, and full surface capping with rock. The results after one wet season indicated that using water diversion banks and rock armouring together on steep road cuts can reduce deep rill and gully scour and fill (from ± 1 m down to ± 0.2 m each year), but will not necessarily reduce short-term (1 year) erosion rates. In some instances without rock surfacing, erosion rates can increase from machine intervention. Using rock armouring of diversion banks and road surfaces can switch the erosion process from rilling and gullying into predominantly raindrop impact and sheet wash erosion. If a poor quality source of rock is used for armouring (Hodgkinson Formation; Figure 25), then short-term erosion rates over a few years can remain elevated until matrix fines are washed from the rock material. The degree that surface lags of coarse rock will provide longer-term protection against raindrop impact and sheet erosion in sodic soils is less clear. Results to 2017 indicated that rock gravel surface lags were holding on and providing soil protection, but needed some ongoing maintenance and touch-up with imported material.

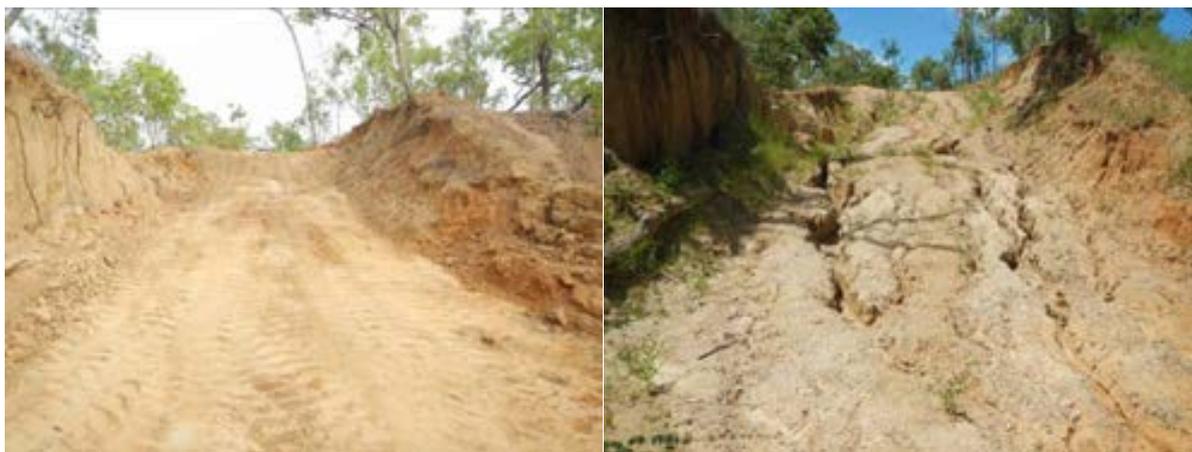
Figure 67 Erosion at road choke points at steep river banks in sodic soils can be severe after whoaboys are installed but without any surface rock capping (Source: Jeff Shellberg).

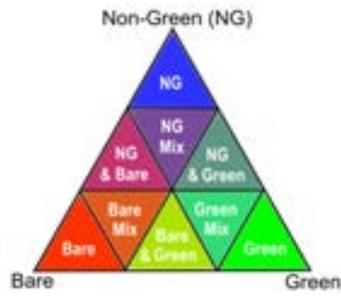
(b). Landsat Fractional Cover for spring 2016.
(30 m resolution)

Figure 69 (a) left, shows the Sentinel-2 fractional cover over Springvale Station for spring 2016 and (b) right, shows the corresponding Landsat Fractional Cover for the spring 2016 for comparison (Source: DSITI).

Figure 69 (a) and (b) shows the Sentinel-2 fractional cover over Springvale Station for spring 2016 and the corresponding Landsat Fractional Cover for the spring 2016 for comparison. There are presently some limitations to the Sentinel-2 product. It is only available as a fractional cover product, without woody vegetation removed to create a ground cover product. The imagery is also only available since the beginning of 2016, making it unsuitable for historical analysis. However, ongoing monitoring should include both Landsat and Sentinel 2 to take advantage of the finer spatial resolution of Sentinel-2 and the long historical record of Landsat. In addition, the combination of the two satellites will help to improve the frequency of monitoring at Springvale Station, potentially further improving seasonal compositing and providing greater ability to monitor in cloudy periods. A Sentinel-2 based seasonal ground cover product is planned for production in the next 12 months.

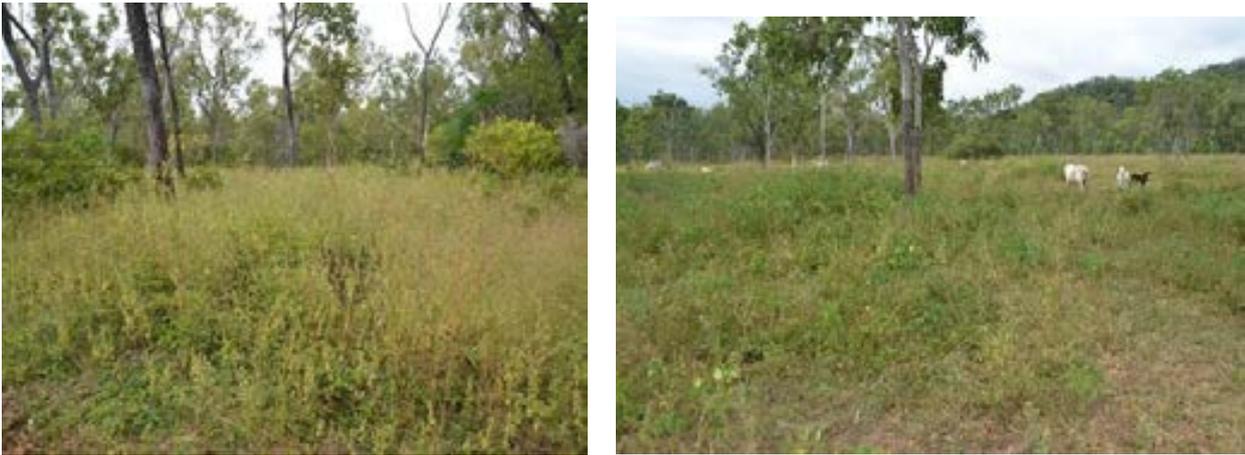
Figure 70 Overgrazing on the frontages (alluvial soils) has taken place over several decades on Springvale Station. In good condition these areas support productive, palatable and perennial grasses (3P). Loss of 3P pastures, weed invasion and some woodland thickening have reduced original carrying capacity by more than 60% (Source: Joe Rolfe).

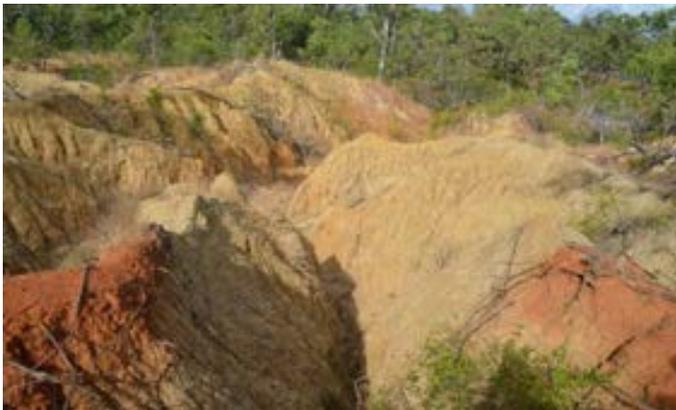
Figure 71 Active gully systems occur throughout the alluvial or frontage land types. Road infrastructure and sustained overgrazing have accelerated the erosion rates of dispersible soils on Springvale Station (Source: Joe Rolfe).

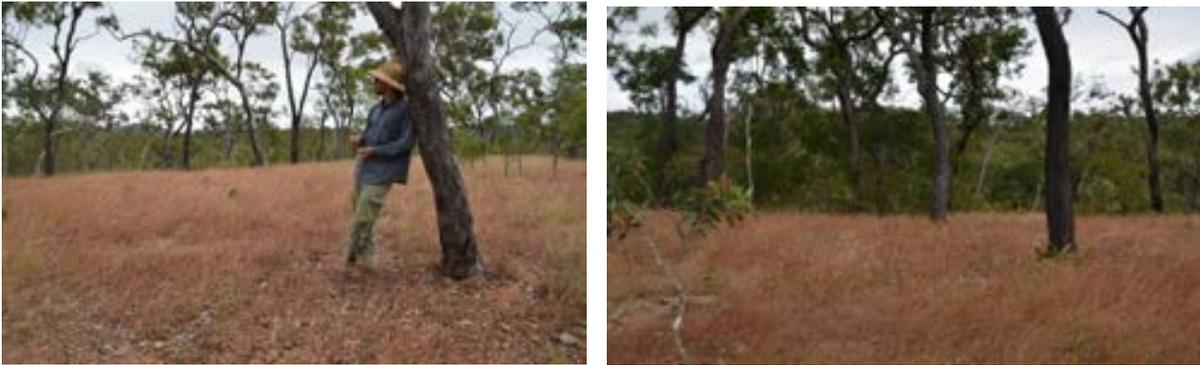
Figure 72 The range country (Hodgkinson-Normanby Formation) covers a significant area of Springvale Station. Cattle access, and therefore overgrazing, has been limited across these skeletal soils due to the steep topography and lack of property infrastructure (Source: Joe Rolfe).

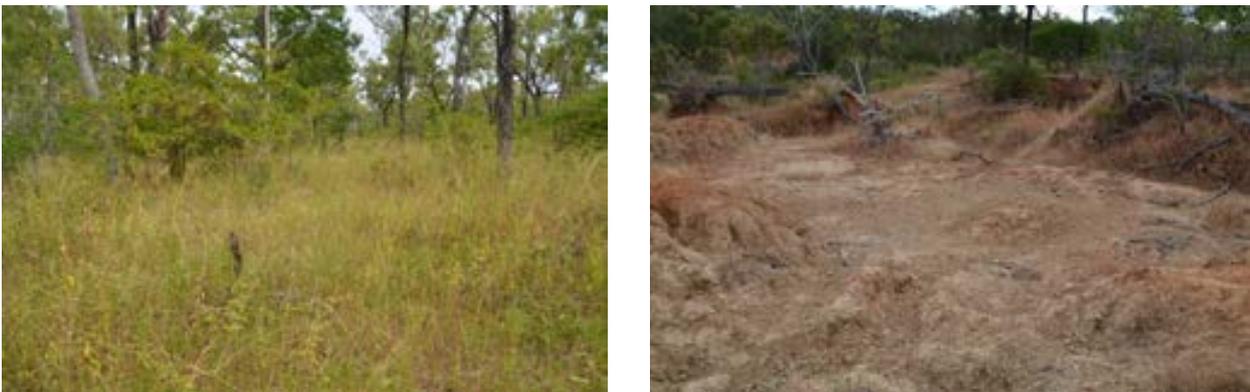
Figure 73 The increase in ground cover since the reduction in stock numbers on Springvale Station is very encouraging (left). Some actively eroding areas continue to be impacted by cattle on Springvale (right) (Source: Joe Rolfe).
