Technical Report to the Springvale Station Erosion Management Plan

Cape York Natural Resource Management 2017

The Springvale Station Erosion Management Plan presents a summary of the recommended implementation approaches for reducing sediment loss from Springvale Station (www.qld.gov.au/environment/coasts-waterways/catchment-management/springvale-station).

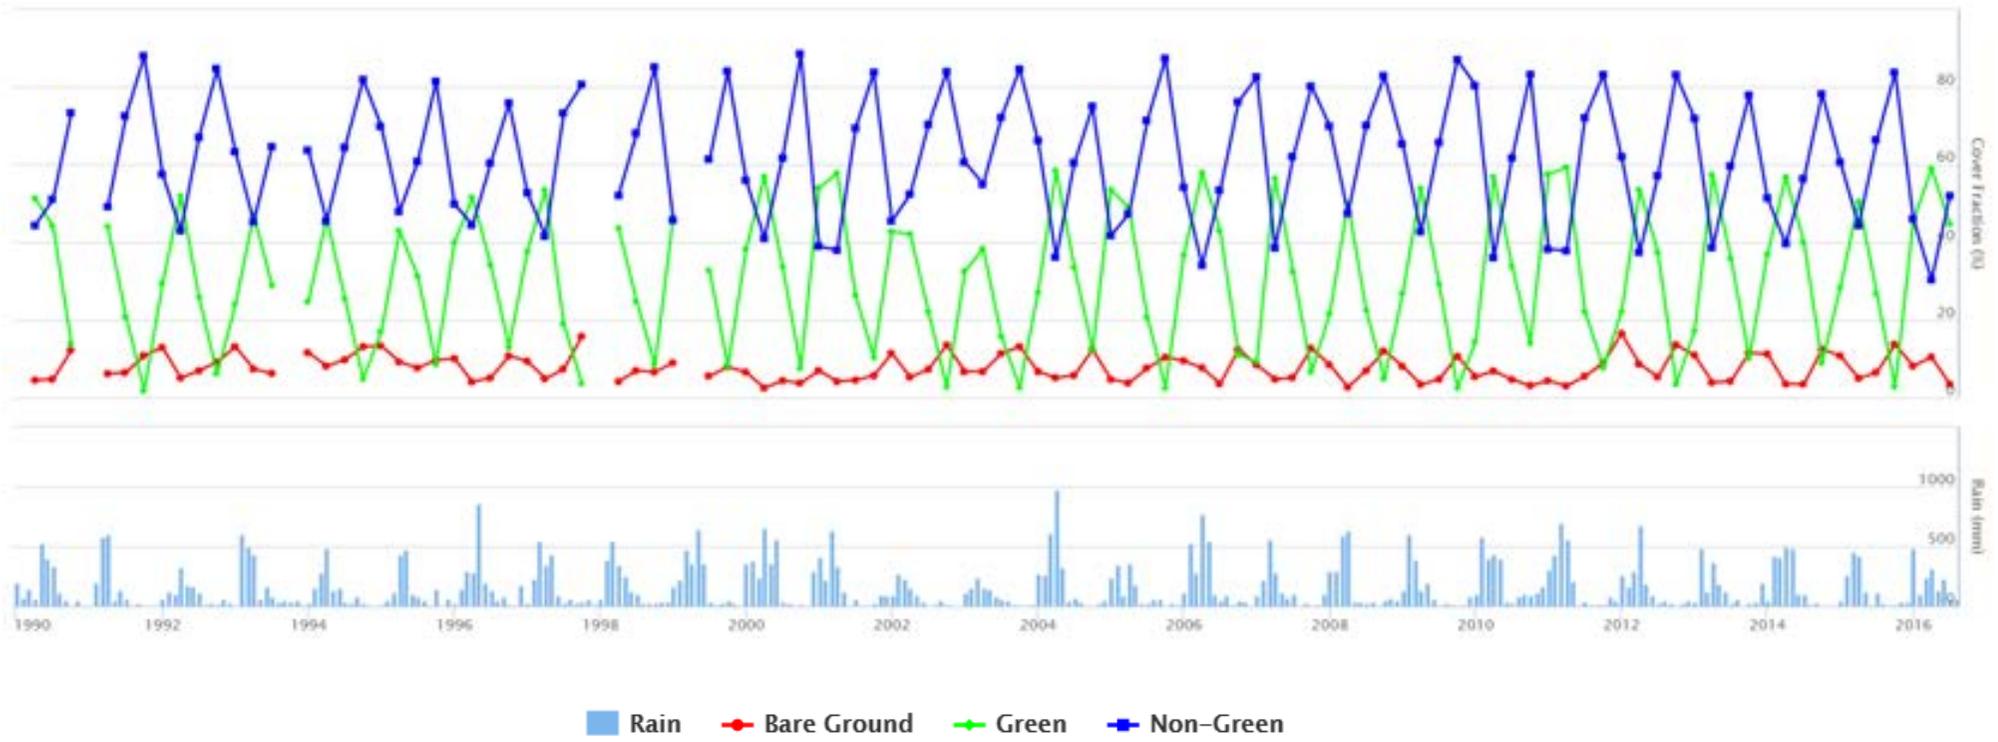
Figure 77 Ground cover and rainfall relationship for 26 years (1990 - 2016) on Springvale Station (Source: DSITI).

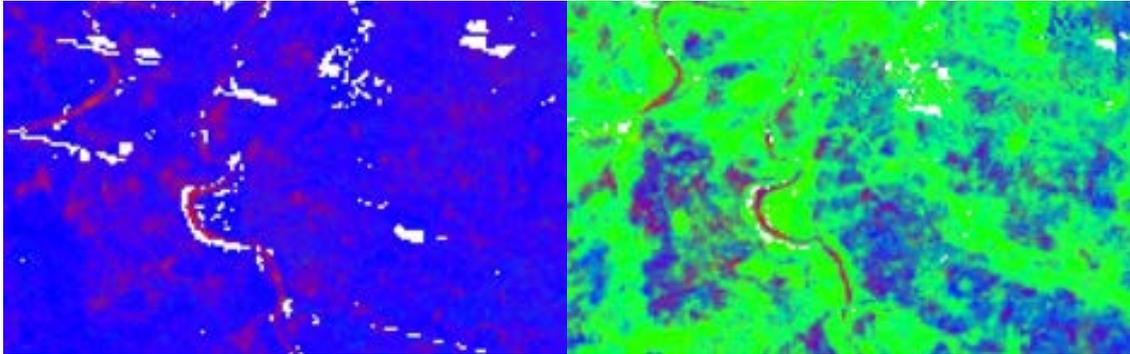
Figure 79 Ground cover over heavily degraded alluvial soils in spring 2016 (left) and summer 2016 (right). Red areas = bare ground, green areas = green ground cover and blue areas = non-green ground cover (Source: DSITI).

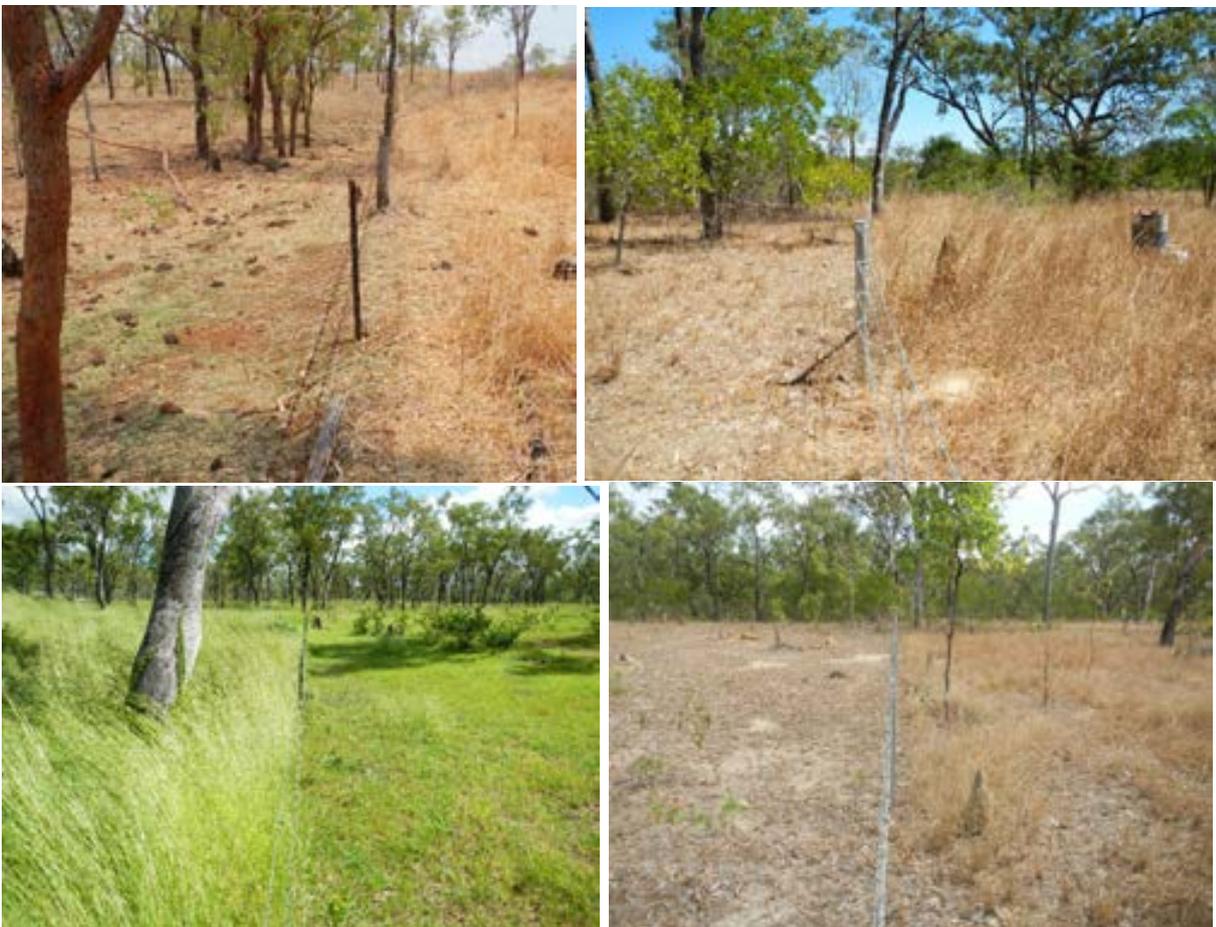
Figure 82 Various examples of grazing pressure influences on pasture grass biomass and ground cover at Springvale Station inside and outside cattle exclusion areas (Source: Shellberg and Brooks, 2013).

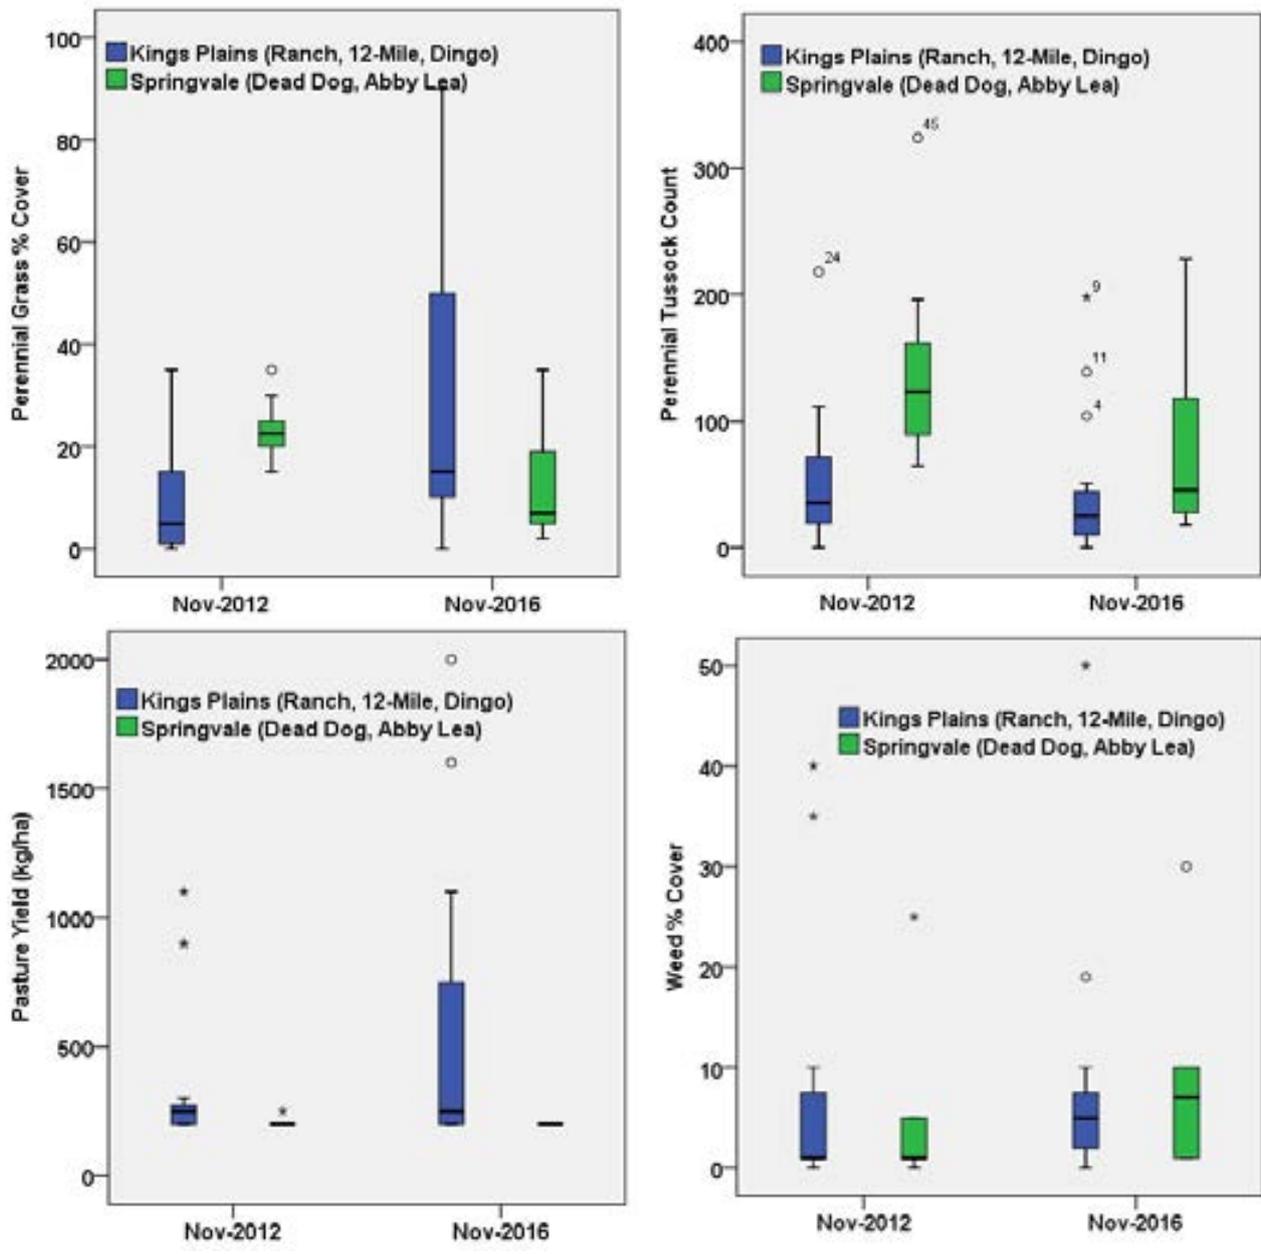
Figure 83 Changes in pasture vegetation conditions between Nov-2012 and Nov-2016 at Kings Plains (n=15) and Springvale Stations (n=10) on high terrace surfaces above gully heads (Source: Shellberg and Segboer, unpublished data).

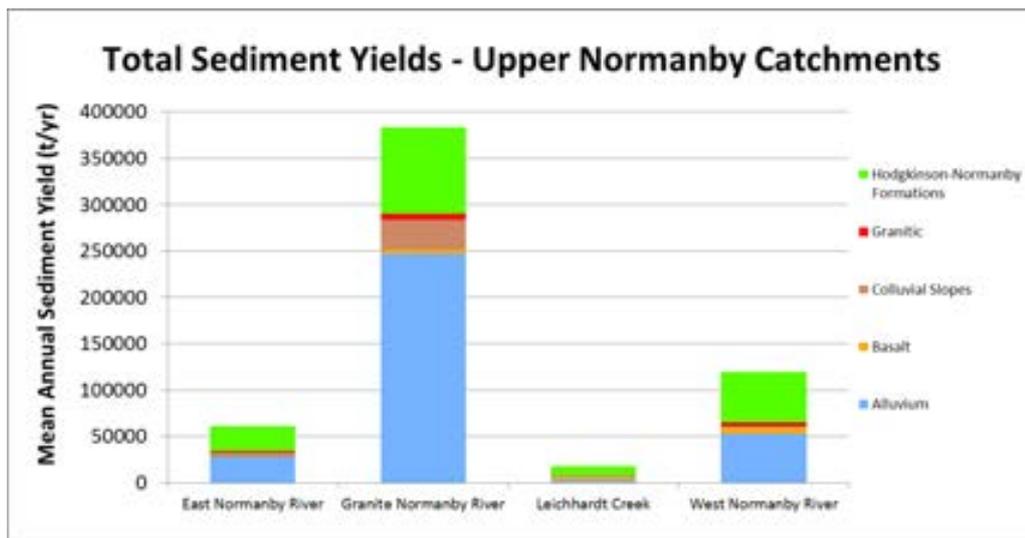
Figure 85 Model estimated total sediment contributions from each sub-catchment broken down by sources from each geological unit for the whole of the upper Normanby catchment down to the stream outlets at the northern property boundary (Source: Griffith University).

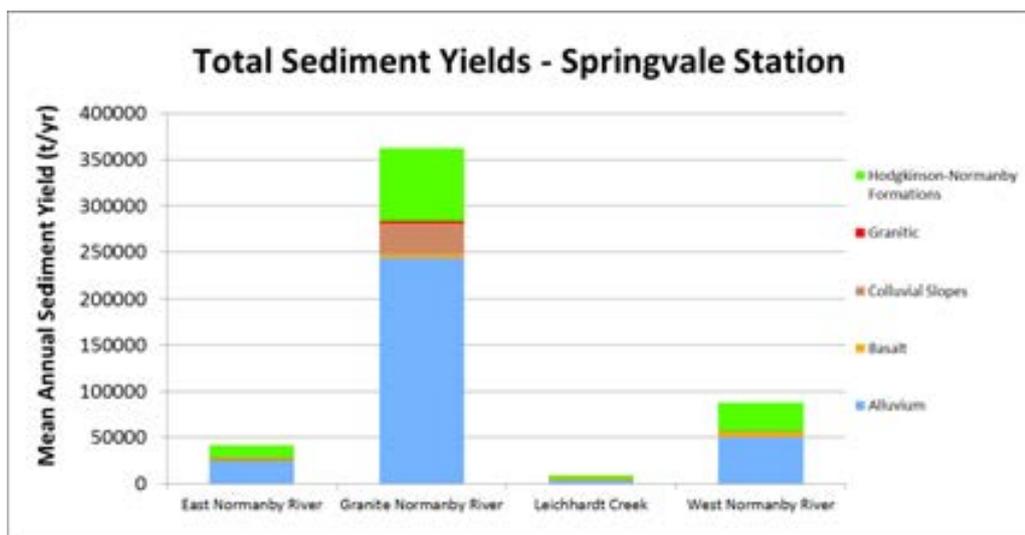
Figure 86 Model estimated sediment yield for the portions of the four major tributaries on Springvale Station broken down by geologic unit (Source: Griffith University).

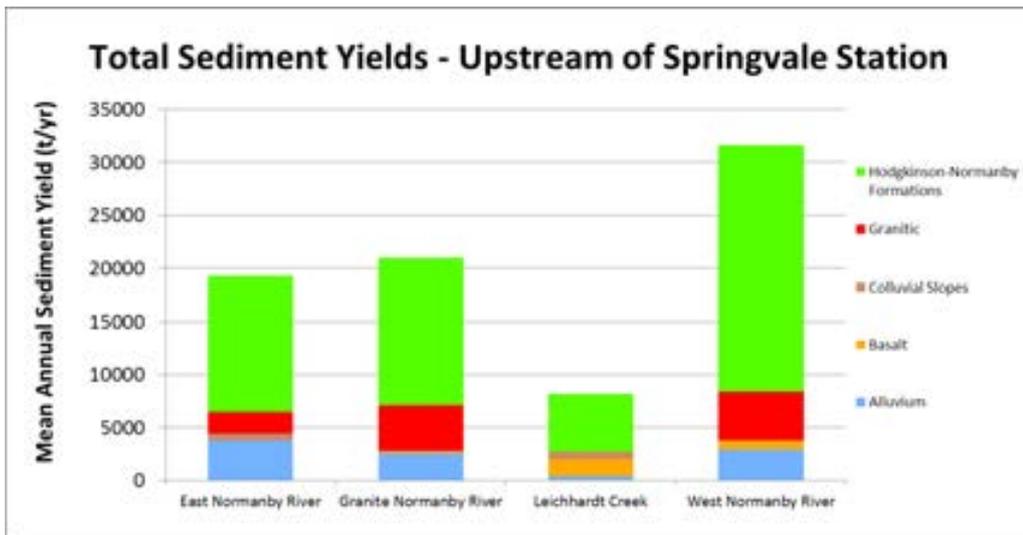
Figure 87 Model estimated sediment yields for contributing sub-catchments upstream of Springvale Station (note the y axis scale is an order of magnitude less than that in Figure 85 and Figure 86 (Source: Griffith University).

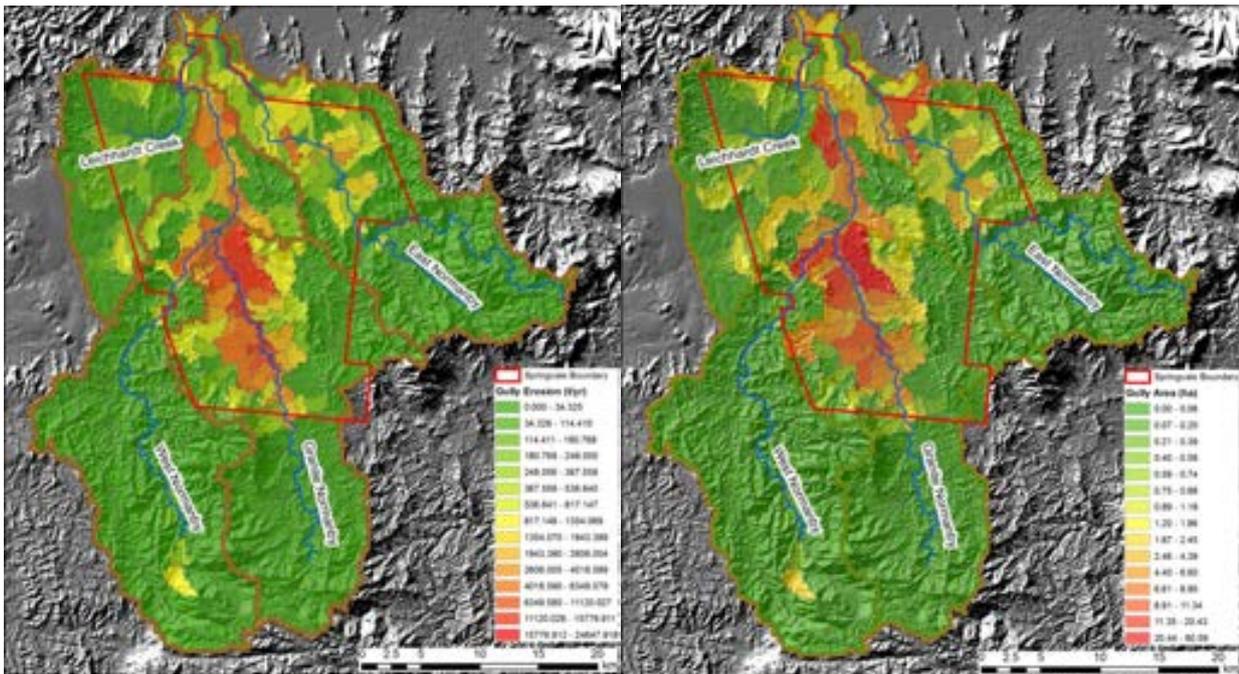
Figure 90 Modeled sediment yields from alluvial and colluvial gully erosion (combined) on Springvale Station and the upper Normanby catchment (Left); and gully area on Springvale Station (Right) (Source: Griffith University).

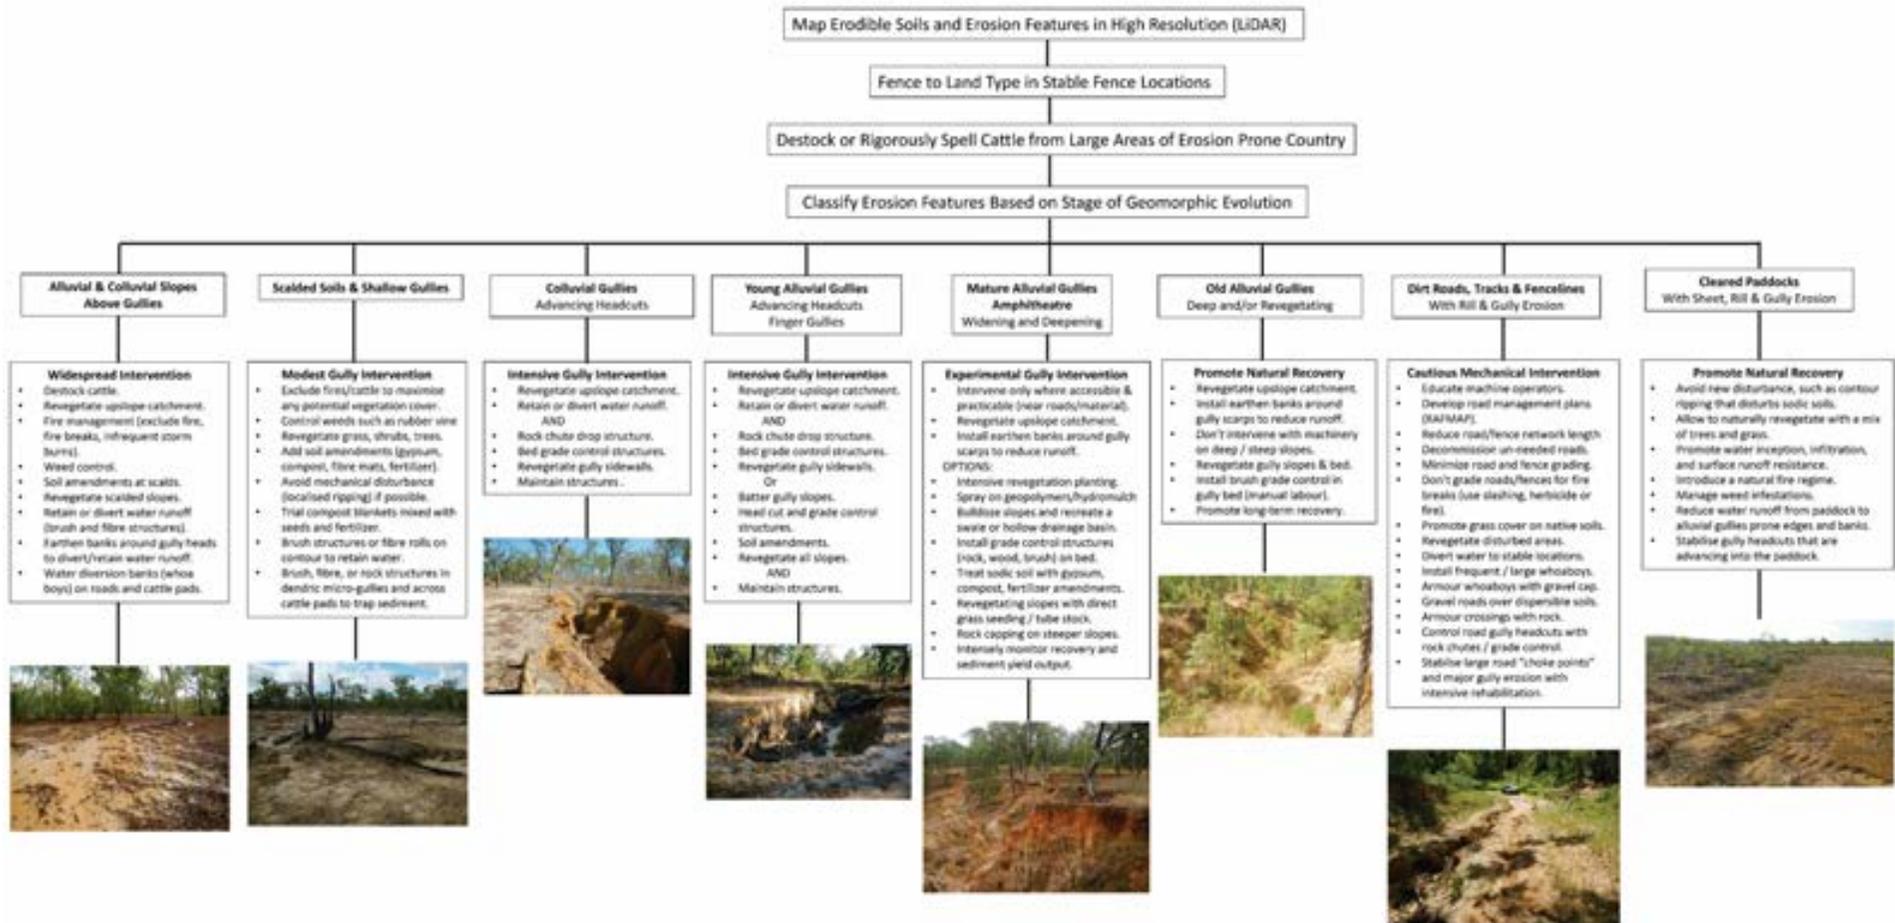
Figure 98 Management guidelines for the soil and gully erosion types on alluvial and colluvial soils present on Springvale Station (Source: updated from Shelberg et al. 2016b) (Refer to Appendix 4 for more detail on rehabilitation, remediation and monitoring options for each erosion type).

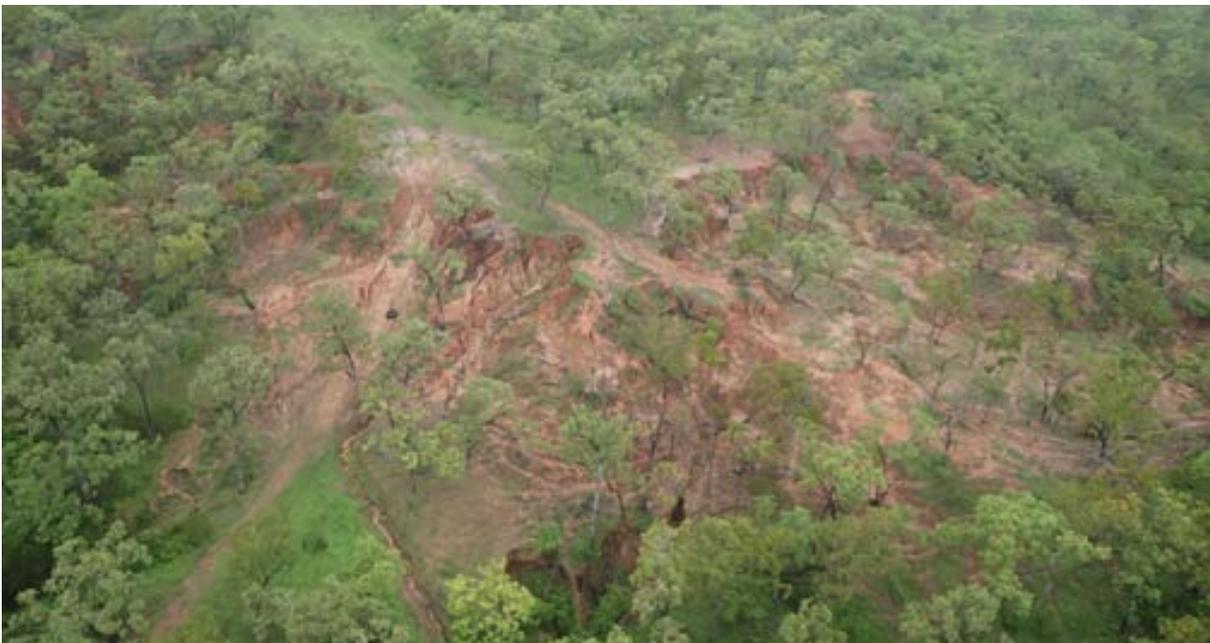
Figure 101 An example of a three-way "road intersection" and "choke point" through a large alluvial gully complex accelerated by historical road and fence use, which could be the site of "No Regrets" activities to both provide stable road access and rehabilitate the surrounding gully complex for sediment reduction goals (Source: Jeff Shellberg).

- Focus on active road gullies, road choke points restricting road access (Figure 102), complemented by a small number of experimental treatments for mature alluvial gully scarps associated with or near road choke points (Figure 101) along the Keetings Road area between the homestead and Keetings Yard.

It is assumed that maintaining access along Granite Normanby Road to Keetings will be a priority for future management access. Alternative routes are difficult -- but possible and should be discussed. It is logical to address the major erosion along the road to Keetings, and other very difficult road sections, to 1) provide property access to other areas of major erosion and management needs (weeds, fire), and 2) to address road erosion caused directly by man and machine. Additional experimental gully rehabilitation works could also be focused at gullied terrain around the 'Choke Points', as machine access by default will be available (Figure 101).

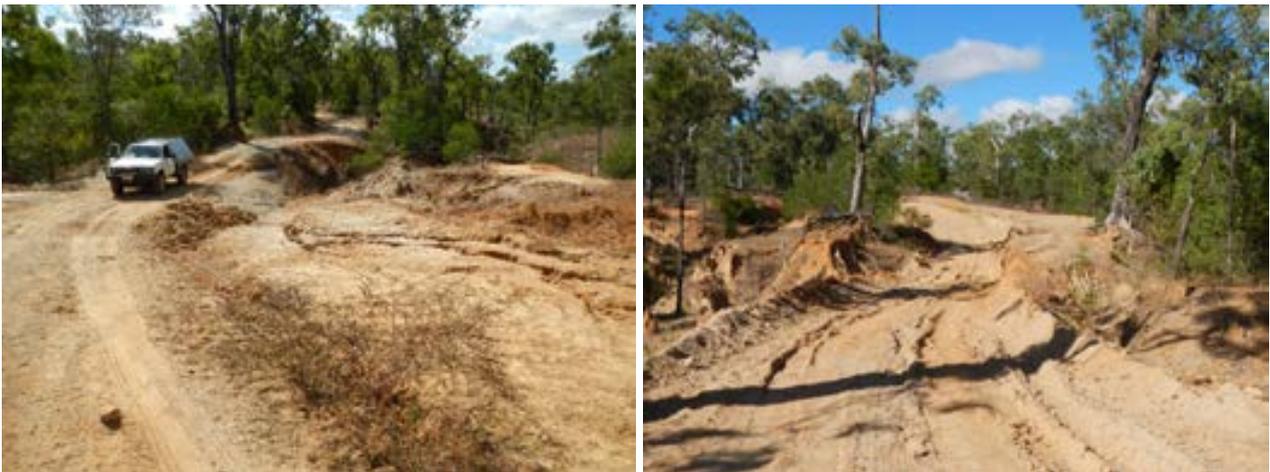
Figure 103 Choke Point erosion and gulling at road gully 18 (Source: Jeff Shellberg).

- Road Gully 17/18 on the West Normanby Keetings Road (Figure 103)
- Road Gully 28/29 on the Granite Normanby Keetings Road (Figure 104)

Specific design ideas for these road “Choke Points” can follow and build upon experiences in Shellberg and Brooks (2013). Stabilizing these points for improved access would entail rock grade control structure within advancing headcuts on either side of the road, battering scarped road edges to a stable slope, and capping the road surface and batters with imported or local rock gravel. Additional revegetation would also be needed, and treatment of exposed sodic soil with gypsum where not capped with rock.

Due to readily available road access to Road Gully 17/18 and 28/29 and need for machinery at these sites, mature alluvial gully scarps in gullied areas adjacent to the suggested road could be used as additional demonstration sites for erosion control. Adjacent gully scarps of mature alluvial gullies at or nearby these road choke points could be used to test major earthwork, battering and revegetation options on big gully walls and scarps (Figure 101). Testing these more intrusive and higher risk techniques are more appropriate near roads and key access points, rather than deeper into more remote parts of Springvale Station with additional values and risks.

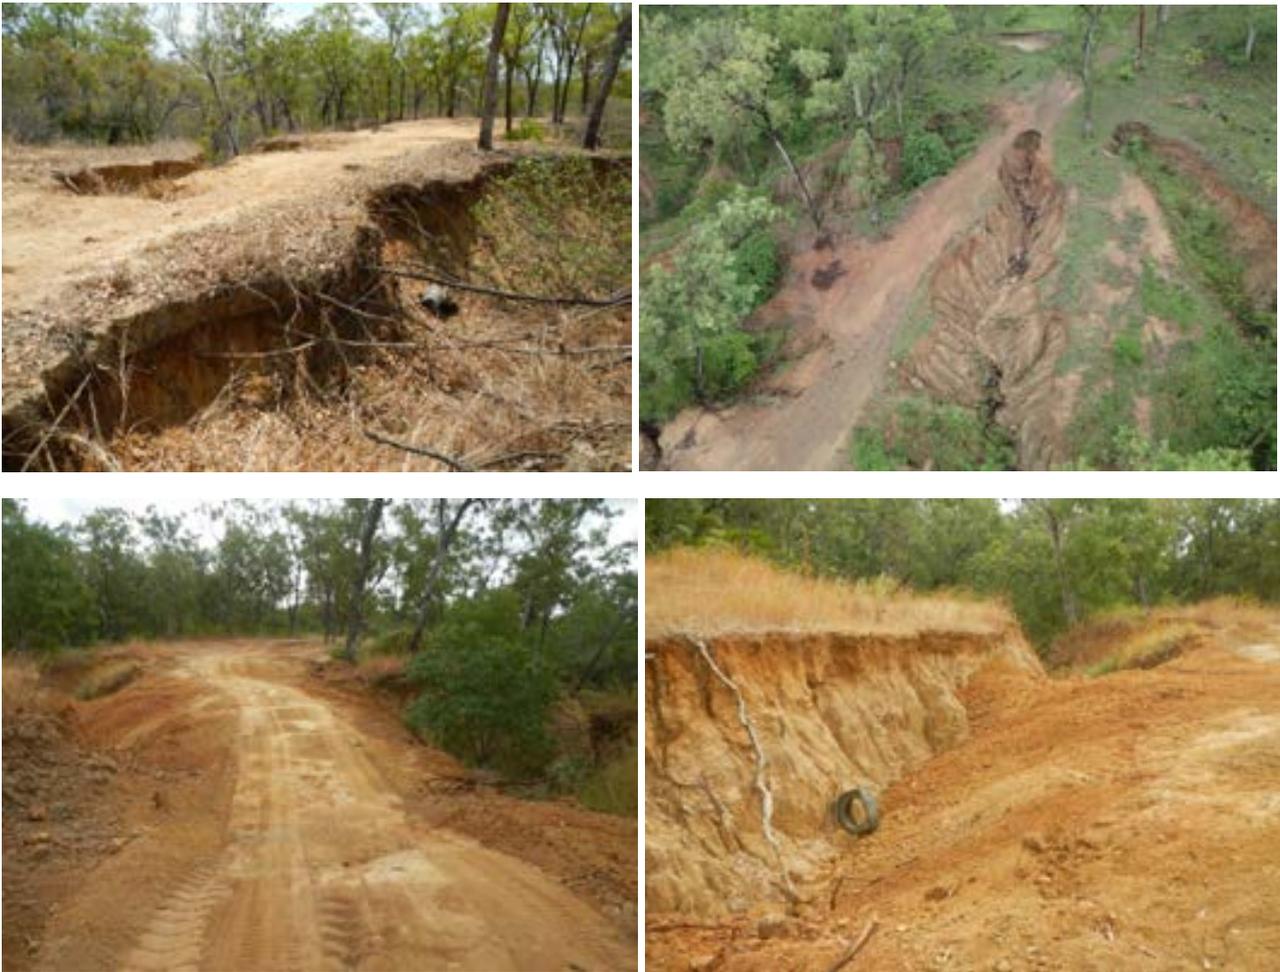
Figure 104 Choke Point erosion and gulling at road gully 29 before (top, 2016) and after (bottom, 2017) regrading to maintain immediate access for cattle management. Stabilizing this sediment will be critical before the 2017/18 wet season (Source: Jeff Shellberg).

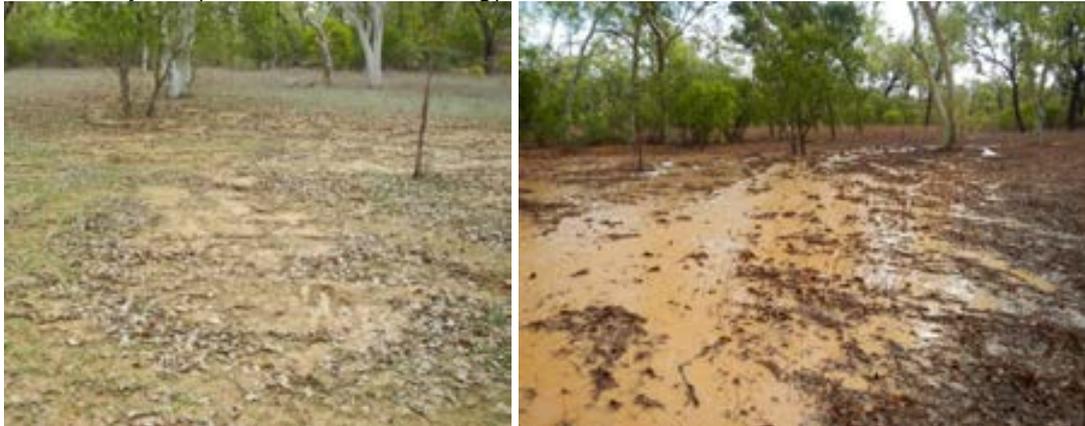
Photo Examples (Source: Jeff Shellberg)

Alluvial and Colluvial Slopes Above Gullies

- Increase perennial grass cover
 - Cattle destocking
 - Active revegetation of grass – direct seeding or tubestock.
- Fire management
 - Locally tailor fire regimes to soil type and vegetation community for specific objectives (i.e. increase perennial grass cover, weed control).

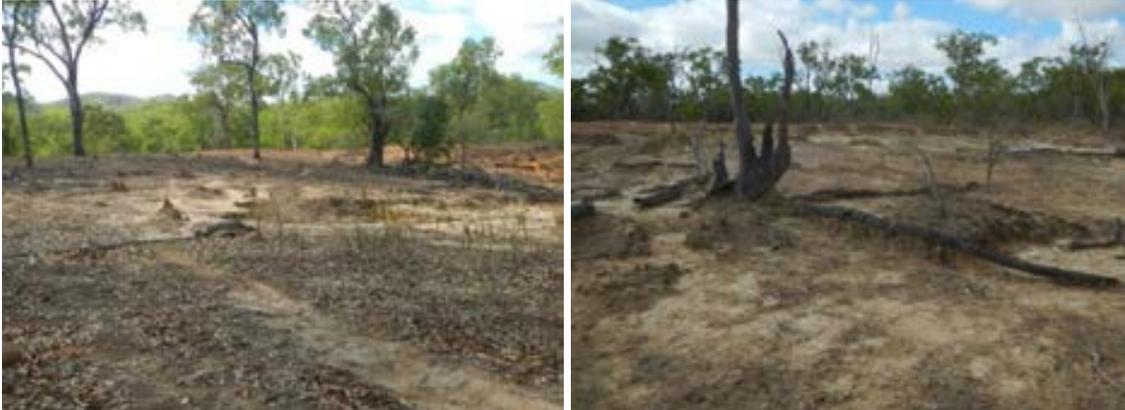
Photo Examples (Source: Jeff Shellberg)

Scalded Soils and Shallow Gullies (alluvium or colluvium)

- Increase perennial grass cover
 - Cattle destocking
 - Active revegetation of grass, shrubs, trees – direct seeding / tubestock.
 - Treat scalded areas with soil amendments (gypsum, compost, fibre mats, fertilizer) without (preferred) or with mechanical disturbance (localised ripping), which has the risk of collateral damage.

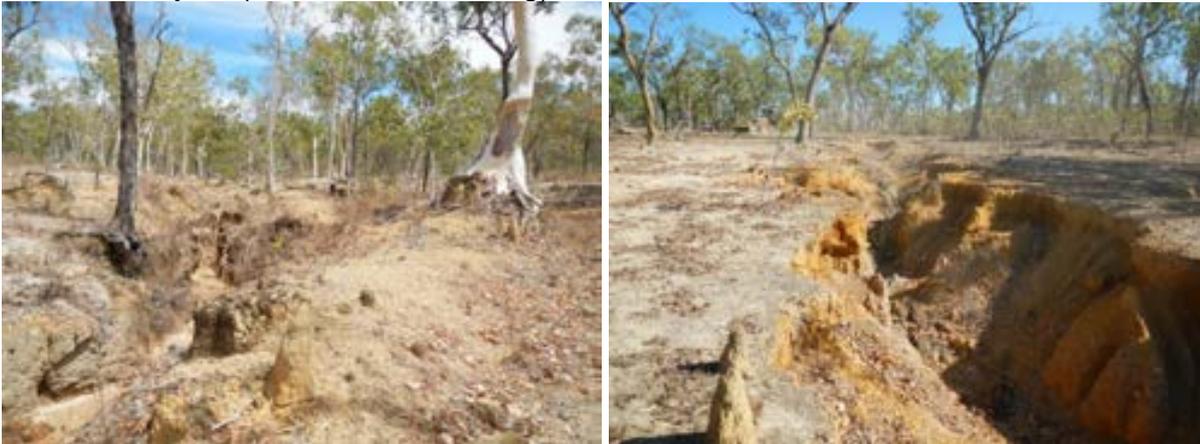
Photo Examples (Source: Jeff Shellberg)

Colluvial Hillslope Gullies (typically linear)

- Reduce water runoff from slopes above gully head (see sections on Alluvial and Colluvial Hillslopes, or Road and Fence Gullies).
- Earthen banks (bunds) around gully heads to retain water runoff and/or divert into safe disposal points, using locally imported material.

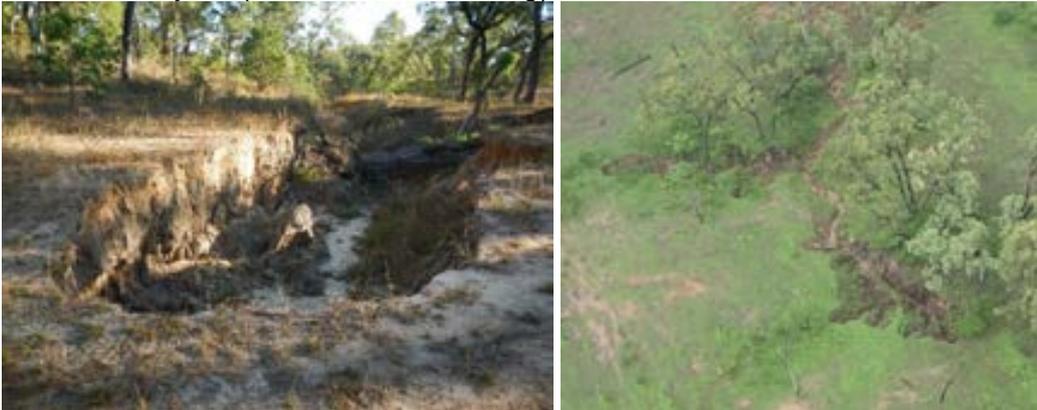
Photo Examples (Source: Jeff Shellberg)

Linear Rapidly Advancing Alluvial Gullies (Finger Gullies)

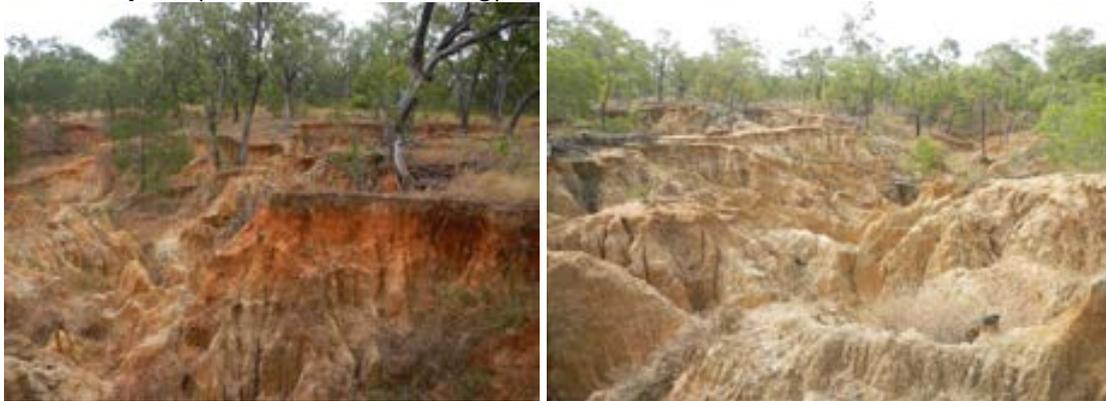
Photo Examples (Source: Jeff Shellberg)

Mature Alluvial Gullies (Amphitheatre)

- Ratio of gully area / to total catchment area (LiDAR derived) to assess contributing catchment area, potential for overland flow input, potential future erosion, and stage of channel evolution.

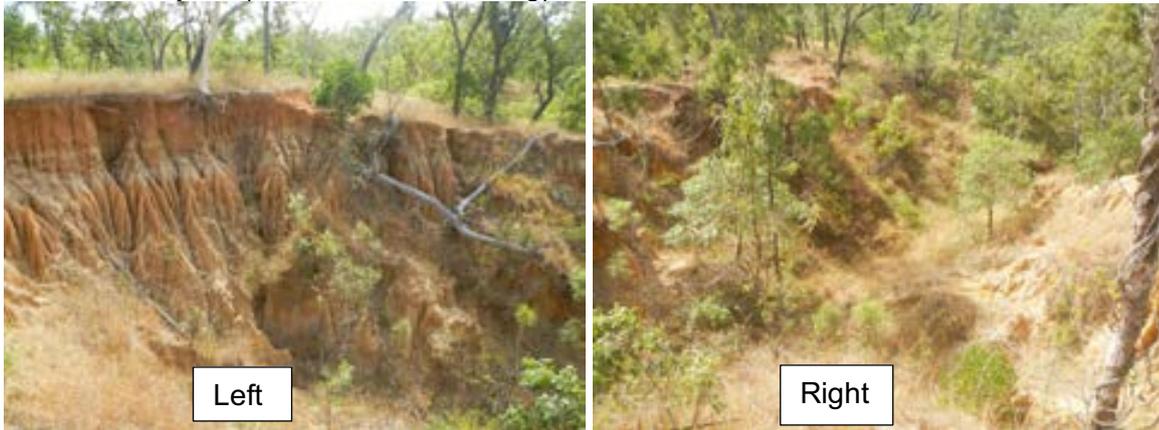
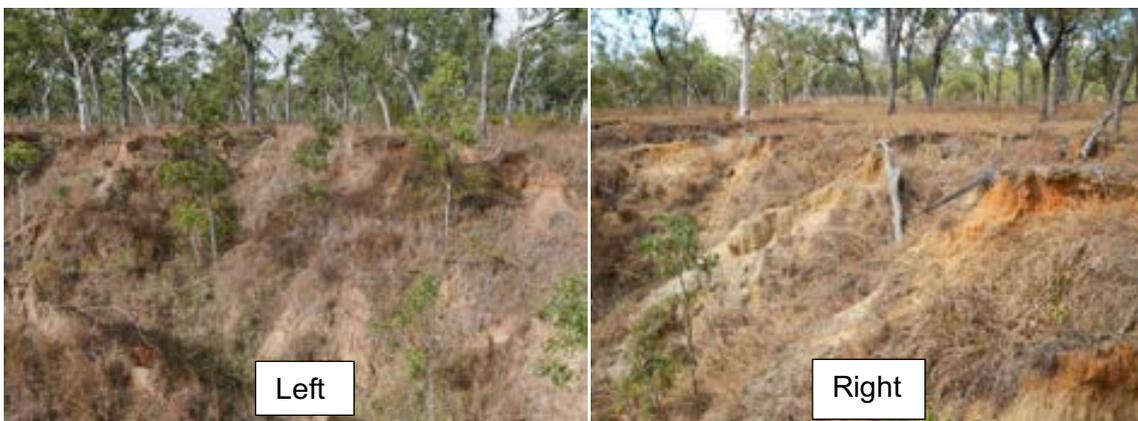
Photo Examples (Source: Jeff Shellberg)

Old Alluvial Gullies (Deep and/or Re-vegetating)

- Some older alluvial gullies have been eroding for 100 years or more, and are still active in places. However, as they incise toward their ultimate base-level, their slopes begin to revegetate with trees and grass. This is especially the case toward the middle and lower reaches of the gully catchment where erosion started first and slopes are stabilising in their evolutionary cycle. Cattle access is often difficult in this very steep terrain.

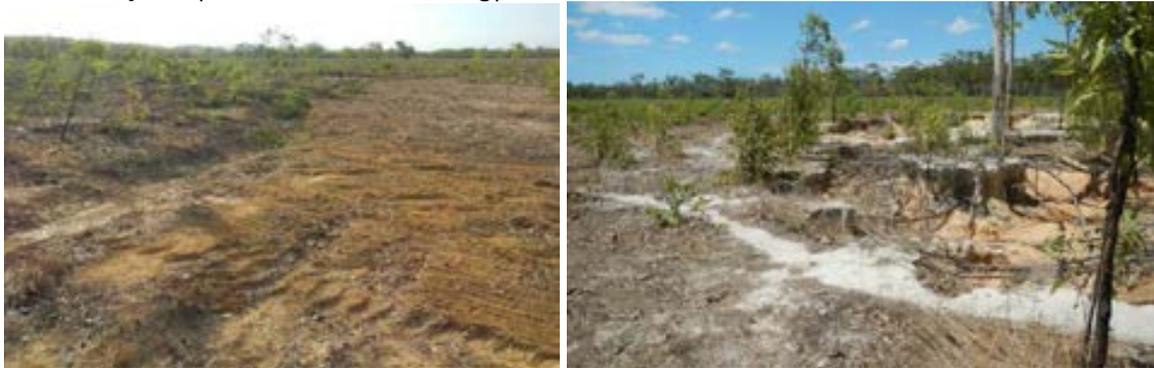
Photo Examples (Source: Jeff Shellberg)

Previously Cleared Paddocks

- Avoid any ongoing disturbance, such as contour ripping, which will further disturb sodic dispersible soils.
- Allow to naturally revegetate with both tree and grass mixes to promote water inception, infiltration, and surface runoff resistance.
- Introduce a natural fire regime that promotes a healthy mix of grass and trees in open woodlands.
- Manage weed infestations in disturbed paddocks.
- Reduce water runoff from paddock edges into alluvial gullies or riparian zones of ephemeral creeks and rivers.
- Install earthen banks (bunds) around gully heads to retain water runoff and/or divert into safe disposal points.
- Stabilise gully headcuts that are advancing into the paddock from the terrace and paddock edge (see Linear Rapidly Advancing Alluvial Gullies above).

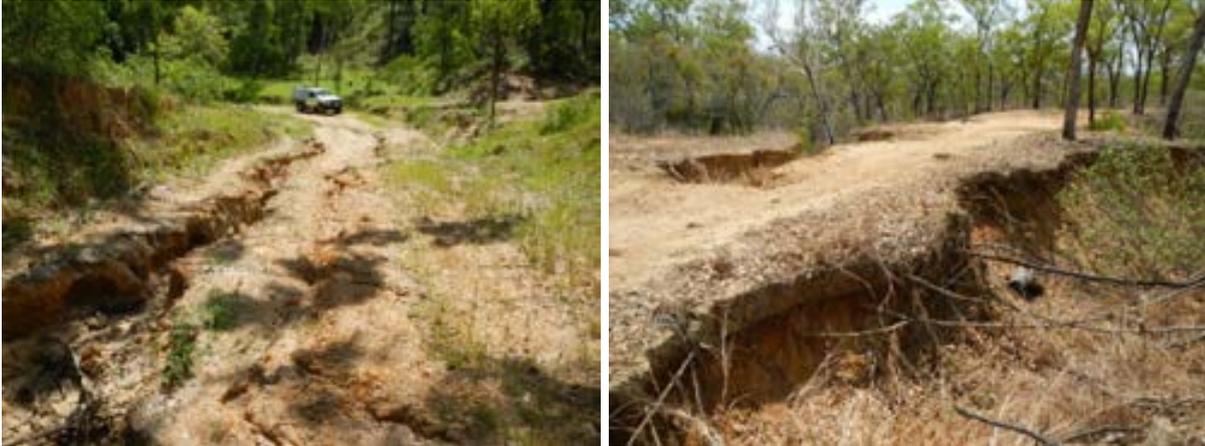
Photo Examples (Source: Jeff Shellberg)

Road and Fence Gullies

- Educate machine operators on Best Management Practices (BMPS)
- Develop Road and Fence Maintenance and Abandonment Plans (RAFMAP)
- Reduce road and fence network length through decommissioning and rehabilitation.
